# Climate Resilient Low-Income Tropical Housing

**Abstract:** Located in East Africa, Uganda is one of the most economically deprived countries that is likely to be dramatically affected by climate change. Over 50% of Ugandan families live in single-roomed overcrowded properties and over 60% of the country's urban population live in slums. Moreover, the gradual shift towards relatively modern and low thermal resistance building materials, in addition to imminent thermal discomfort due to global warming, may considerably affect the health and wellbeing of low-income people, the majority of whom live in low quality homes with very little or no access to basic amenities. This paper evaluates the effects of various construction methods as well as refurbishment strategies on thermal comfort in low-income houses in Uganda. It is aimed at helping low-income populations adapt to climate changes by developing simple, effective and affordable refurbishment strategies that could easily be applied to existing buildings. Dynamic thermal simulations are conducted in EnergyPlus. The adaptive model defined in BS EN 15251 and CIBSE TM52 is used to evaluate the risk and extent of thermal discomfort

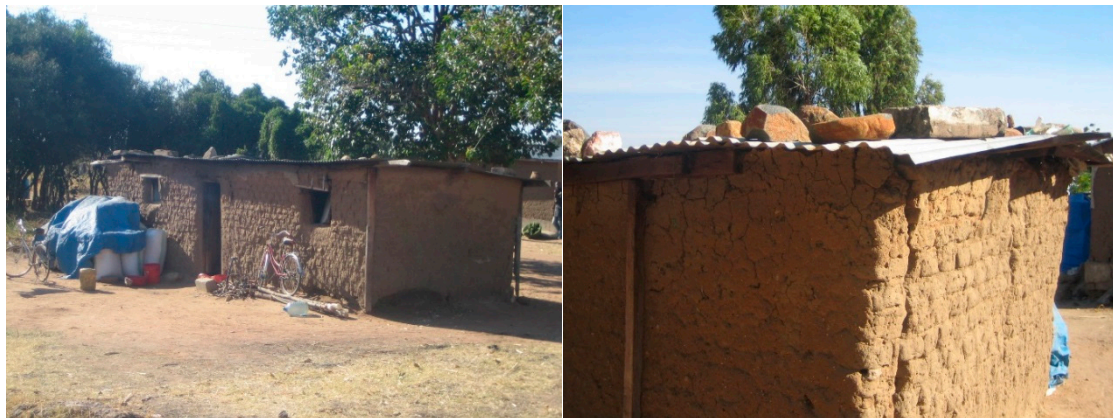
**Figure 2.** A low-income house with clay walls and an iron sheet roof.

Around 62% of homes in Uganda are covered with iron sheets (Figure 2) and 37% have thatched roofs. Brick walling is the most common walling material (57%) followed by mud and poles (39%). With a share of over 70%, cement/concrete flooring is the most common flooring method/material in urban areas of the country [6,16]. The available data indicate that there is a growing shift away from traditional materials (such as adobe and thatch) towards relatively modern methods and materials (such as bricks and iron sheets) [12,13].

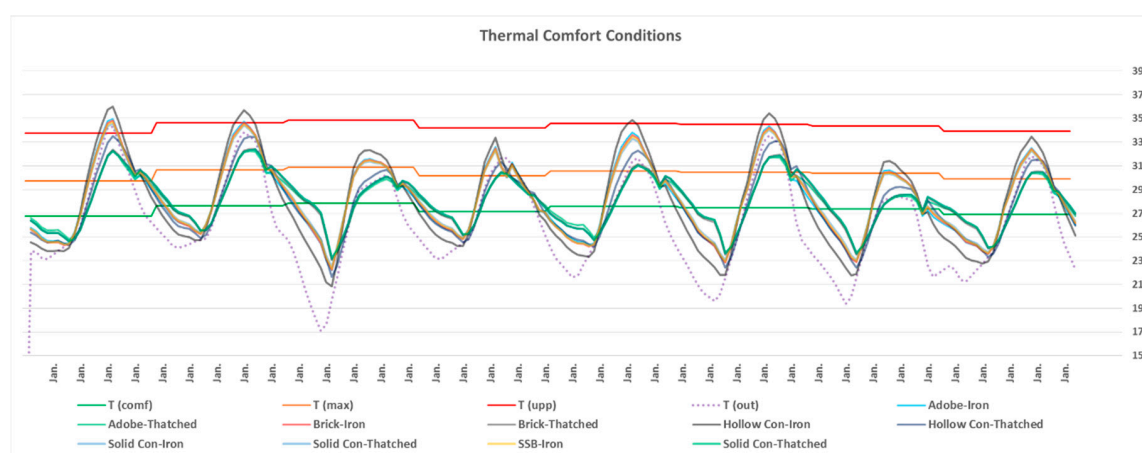
Figure 3 compares the performance of the tested scenarios over a hot summer week during the 24th to 31st of January. According to the results, the most critical factor affecting occupants' thermal comfort in the studied scenarios is the roof construction method/material. Apart from hollow concrete blocks, all walling methods with thatched roofs passed the thermal comfort requirements (passed at least two criteria out of three). For iron sheet roofing, buildings failed all three thermal comfort criteria regardless of walling method/material.

**Figure 3.** Thermal comfort conditions for tested construction methods during a hot summer week in January.

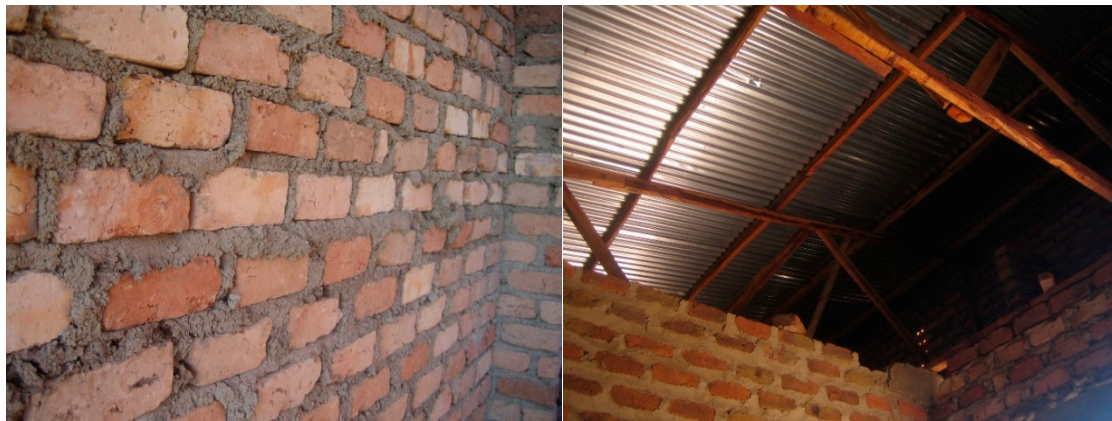
**Figure 5.** Brick walling and iron sheet roofing is the prevailing construction method in Uganda.

The aim of Section B is to identify simple and effective refurbishment strategies to improve thermal comfort conditions in the existing naturally ventilated low-income houses in Kampala. Although, according to the results of Section A, hollow concrete block walls with an iron sheet roof had the worst performance, all other walling materials combined with iron sheet roofing resulted in critical conditions and failed to provide acceptable thermal comfort conditions. Considering the share of brick walling (57%) and iron sheet roofs (62%) in Uganda [16], arguably the majority of low-income houses in Uganda are made from brick walls and iron sheet roofs (Figure 5). The refurbishment strategies are therefore investigated for brick walls and iron sheet roofs as the most common method of construction in Uganda.

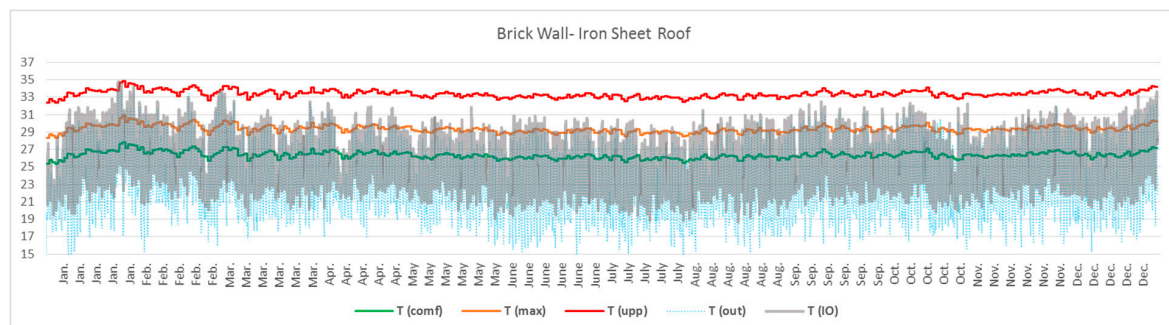
Figure 6 shows the thermal performance of brick walls with iron sheet roofing (explained in Section A) as the base case for comparison in Section B.

**Figure 6.** Thermal comfort condition for the base case (Brick Walls & Iron Sheet Roof).

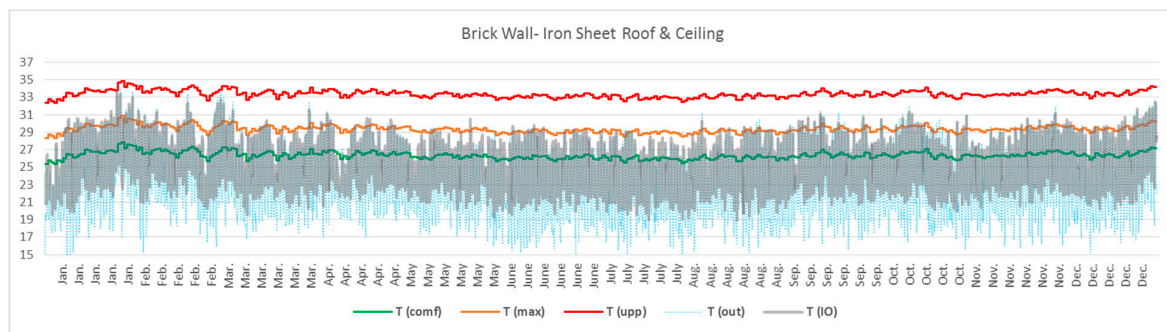
Inclusion of false ceiling significantly improved the conditions and helped to pass two out of the three thermal comfort criteria. The indoor operative temperature was for 2.57% of occupied periods by 1 K or more above the limiting maximum acceptable temperature, meaning that it passed the first Criterion. The building, however, failed Criterion 2, as  $W_e$  exceeded the limiting six degree hours for ten days (2.7% of occupied periods). As for Criterion 3 ( $\Delta T$  exceeding 4 K), there were zero hours during which  $\Delta T$  exceeded the “upper limit temperature” ( $T_{upp}$ ). Overall, the building proved to be more thermally comfortable compared to the base case (brick walls and iron sheet roof). Figure 7 shows thermal comfort conditions during the entire year for brick walls with iron sheet roof and plasterboard ceiling.

**Figure 7.** Thermal comfort condition for brick walls with iron sheet roof and plasterboard ceiling.

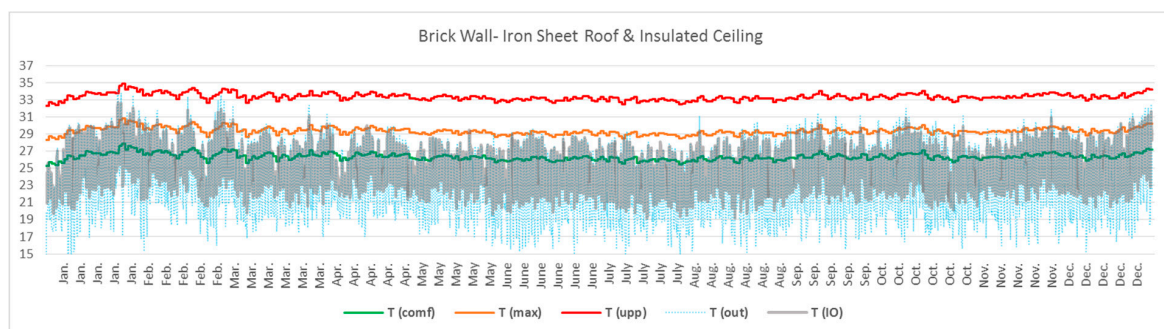
As expected, including 50 mm of insulation above the ceiling further improved the conditions, although the improvement was marginal. The results of simulations revealed that brick walls with iron sheet roof and insulated ceiling passed Criterion 1 and 3, but, similar to the above, failed Criterion 2 with seven days exceeding the acceptable conditions. The indoor operative temperature was for 1.02% of occupied periods by 1 K or more above the limiting maximum acceptable temperature; however,  $\Delta T$  never exceeded the maximum temperature by more than 4 K. Figure 8 shows the results of simulations for brick walls with iron sheet roof and insulated ceiling construction.

**Figure 8.** Thermal comfort condition for brick walls with iron sheet roof and insulated ceiling.

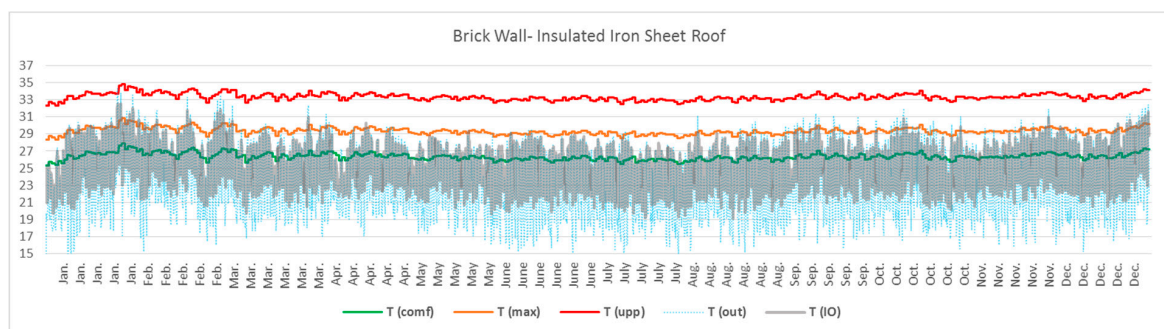
Roof insulation also improved the conditions. Both insulated ceiling and insulated roof achieved almost the same results. According to the results, for insulated iron sheet roof, the building was thermally uncomfortable for 0.97% of occupied periods, and  $W_e$  exceeded the acceptable limit for seven days. The building passed Criterion 3 as  $\Delta T$  never exceeded the upper limit temperature ( $T_{upp}$ ). Figure 9 illustrates the results of simulations for brick walls with an insulated iron sheet roof.

**Figure 9.** Thermal comfort condition for brick walls with insulated iron sheet roof.

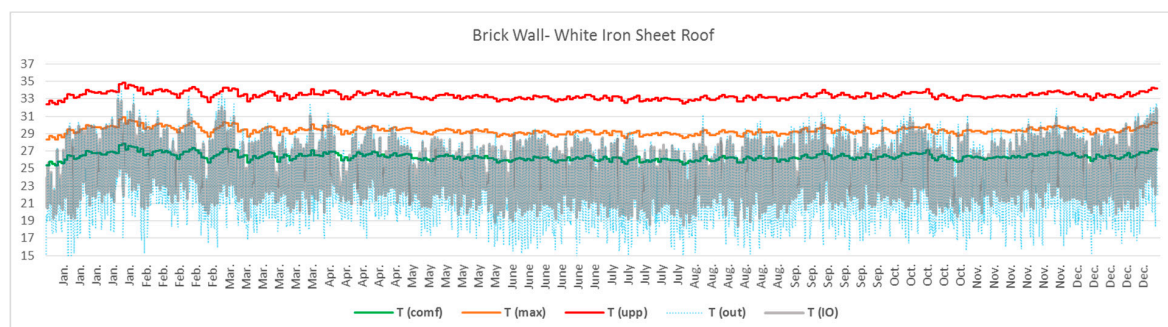
White iron sheet roof, with low solar absorptance of 0.2, achieved a considerably good performance in terms of thermal comfort compared to other refurbishment strategies. According to the results, the thermal performance of the painted iron sheet roof was significantly better than the base case with an ordinary iron sheet roof. However, similar to other refurbishment methods, white iron sheet roof failed Criterion 2 of TM52 comfort criteria. The results indicate that the building was thermally uncomfortable only for 1.11% of occupied periods, and  $W_e$  exceeded the acceptable limit for six days. Moreover, similar to other refurbishment strategies,  $\Delta T$  never exceeded the 4 °C limit. Figure 10 shows the results of simulations for brick walls with painted iron sheet roof.

Figure 10. Thermal comfort condition for brick walls with painted iron sheet roof.

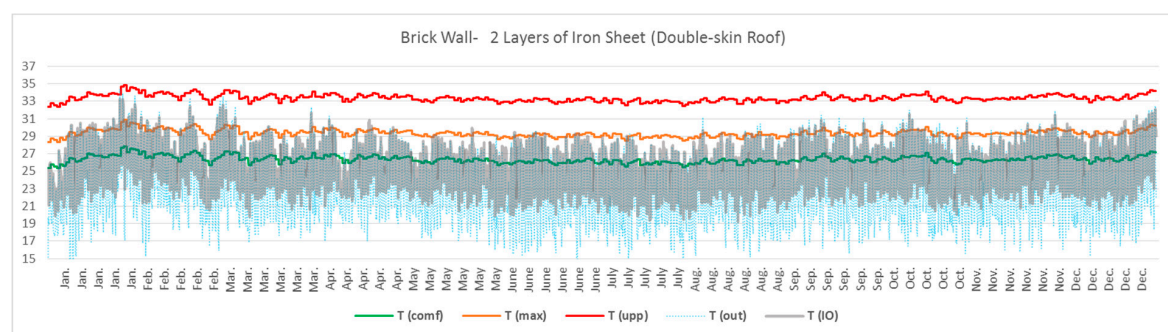
An additional layer of iron sheet above the existing roof (double-skin iron sheet roofing) achieved similar performance to the false plasterboard ceiling, explained above. For the double-skin roof, the building was found to be for 2.37% of occupied periods uncomfortable (Criterion 1).  $W_e$  was also above the acceptable limit for nine days (Criterion 2). As for Criterion 3,  $\Delta T$  did not exceed the limiting temperature. Overall, similar to all other refurbishment strategies, double skin roofing passed the thermal comfort requirements, as it failed in only one Criterion out of three. Figure 11 illustrates the thermal comfort conditions for a double-skin iron sheet roof.

Figure 11. Thermal comfort condition for double-skin iron sheet roof.

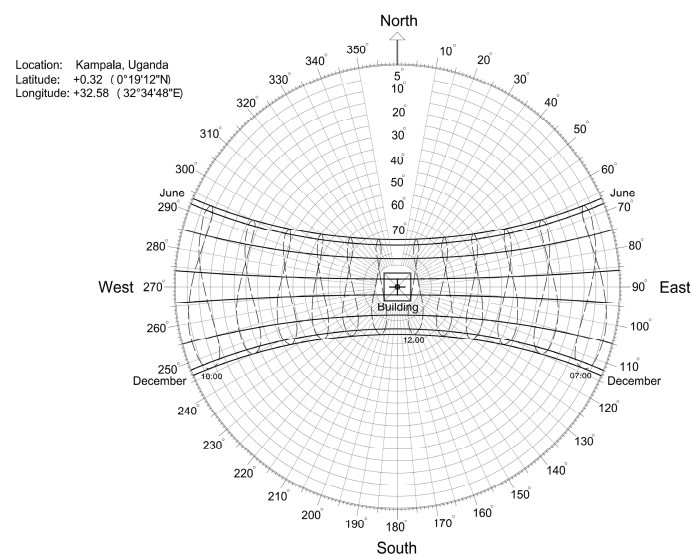
Figure 12 shows the sun path diagram in Kampala. According to the figure, the sun falls on south facing walls during December and on north facing walls during June. Higher solar transmittance is therefore expected during the hottest periods of the year from south facing windows. Table 6 confirms this finding. According to Table 6, transmitted solar radiation through the window in January and December is over 100% more than the periods between March and September. However, due to the relatively small size of the window in this study, transmitted solar radiation through the window is not a major issue. Solar transmittance could, however, become a major issue for large windows/openings in Kampala.

Figure 12. Sun path diagram for Kampala.

Moreover, according to Figure 12, the sun has a very high altitude during the entire year, which indicates considerably higher solar heat gain through the roof compared to other building elements. This is supported by Figure 13, which shows the average monthly and annual solar radiation rates per area for the walls and roofs.

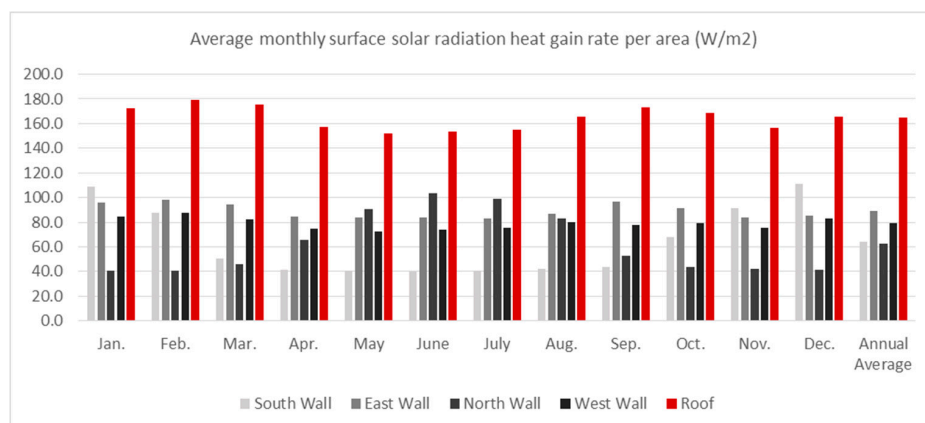
According to Figure 13, the average annual heat gain of the roof is over 2.6 times higher than other elements of the buildings. The average monthly heat gain from the roof has, in some cases (e.g., during February), been over four times more than from the walls. This supports the findings of Section A, which highlighted the roof as the key element affecting thermal comfort in Kampala.

Figure 13. Average monthly and annual surface solar radiation heat gain rate per area ( $\text{W}/\text{m}^2$ ).
