# Wind farms and blanket peat

a report on the Derrybrien bog slide

**The Bog Slide of 16th October 2003  
at Derrybrien, Co. Galway, Ireland**

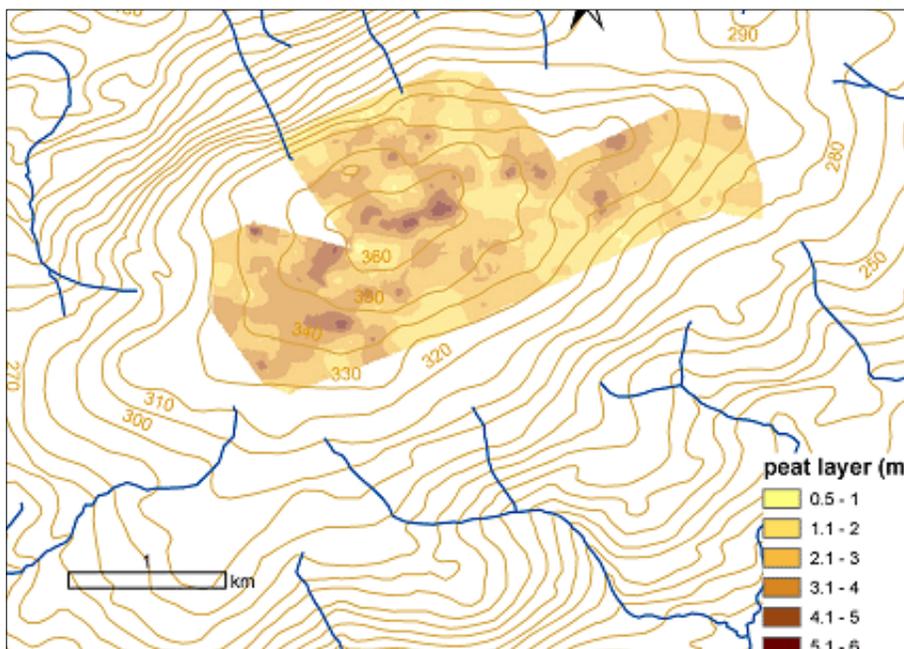
**Figure 2.1: The depth of peat recorded for Cashlaundrumlahan within the area of development.**  
Surface contours give some indication of slope, while the streamlines indicate patterns of drainage.

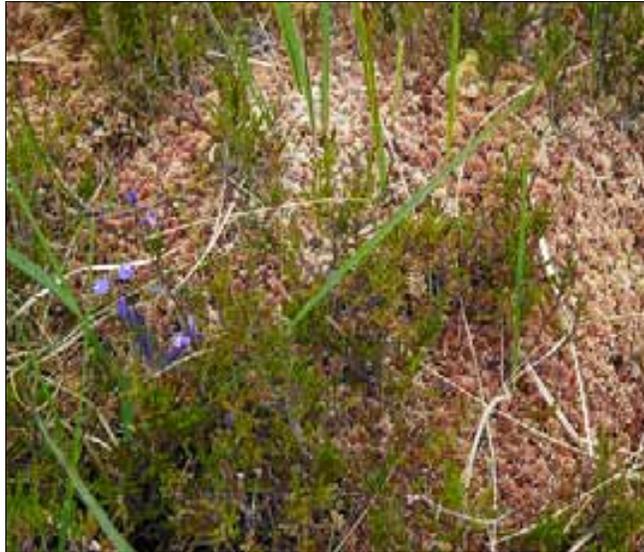
Plate 2.1: Typical Derrybrien bog vegetation, with heath milkwort (*Polygala serpyllifolia*) and purple moor grass (*Molinia caerulea*) as characteristic oceanic species within a bog moss (*Sphagnum capillifolium*) hummock [nanotope] capped by heather (*Calluna vulgaris*).

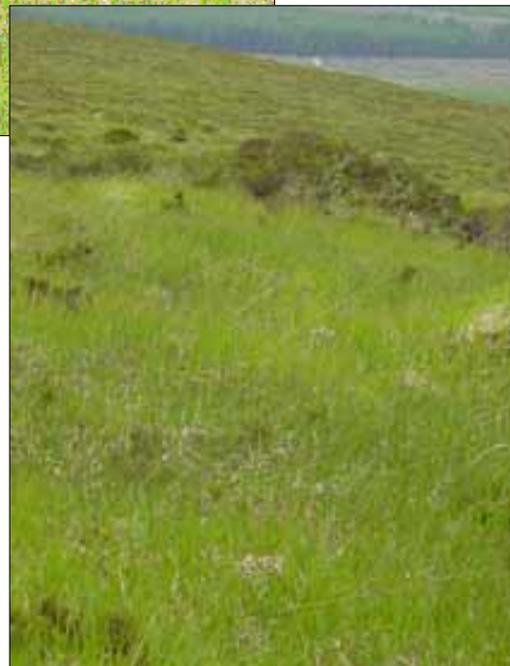
**Plates 2.2:** Typical view across the northern slopes of the watershed blanket mire (mesotope) that dominates the summit of Cashlaundrumlahan. In the upper photograph a series of hummocks (nanotopes) can be seen as a repeated structural motif (microtope) scattered across the slope but, in this case, there are no pools, only terrestrial elements forming the microtope pattern.

In the case of Cashlaundrumlahan, the blanket mire complex (macrotope) represents the whole assemblage of peatland units that interlink to form the continuous peat landscape centred around, and dominating, the Cashlaundrumlahan massif. These individual peat systems are now quite difficult to see because extensive forestry has obscured much of the blanket mire structure. Nevertheless, a small portion of characteristic watershed mire can be seen on the summit ridge, where an area of bog pools has not been ploughed for forestry. Here, the bog surface shows a repeated pattern (microtope) of pools and intervening ridges on which there are both high and low hummocks. Some of the blanket mire features still to be found are illustrated in plates 2.1 to 2.3.

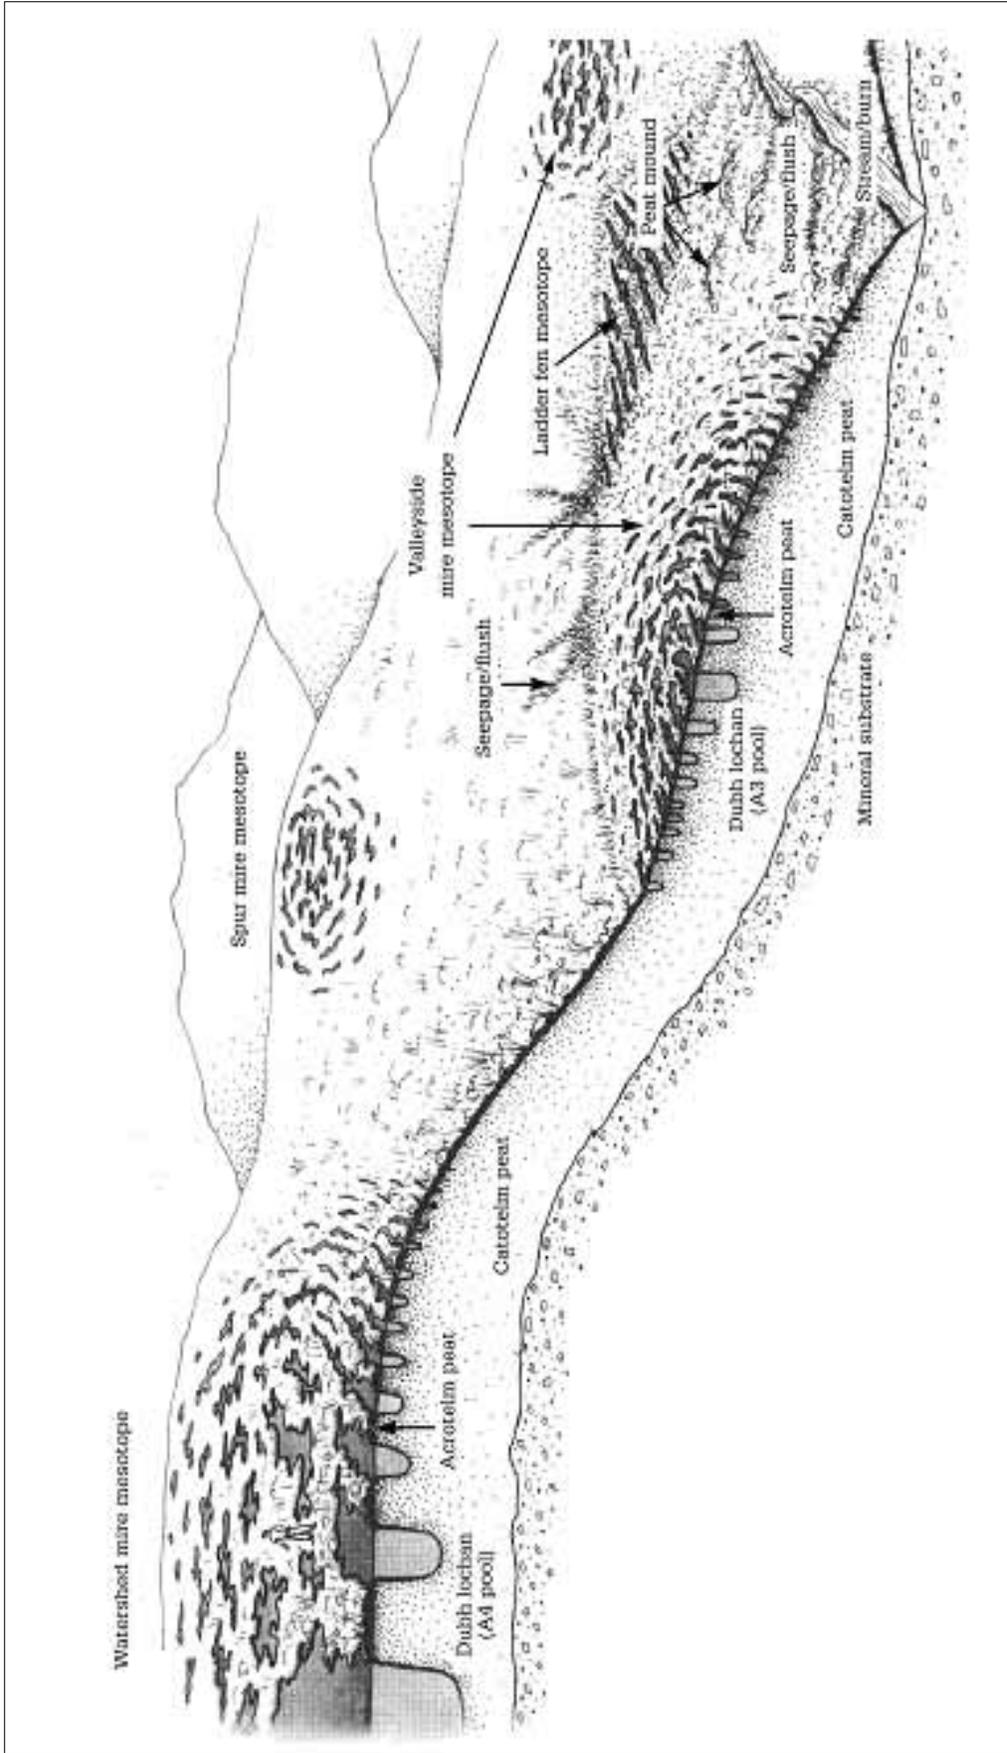
Figure 2.2: Schematic representation of blanket mire, adapted from Lindsay et al. (1988), showing the relationship between peat depth and slope of the underlying mineral substrate as well as the physical (and associated hydrological) inter-relationships between the various structural components of a blanket bog complex [or macrotope]. Terms are explained in sections 2.4.1 and 2.4.2. (Depth of peat exaggerated compared to horizontal scale).

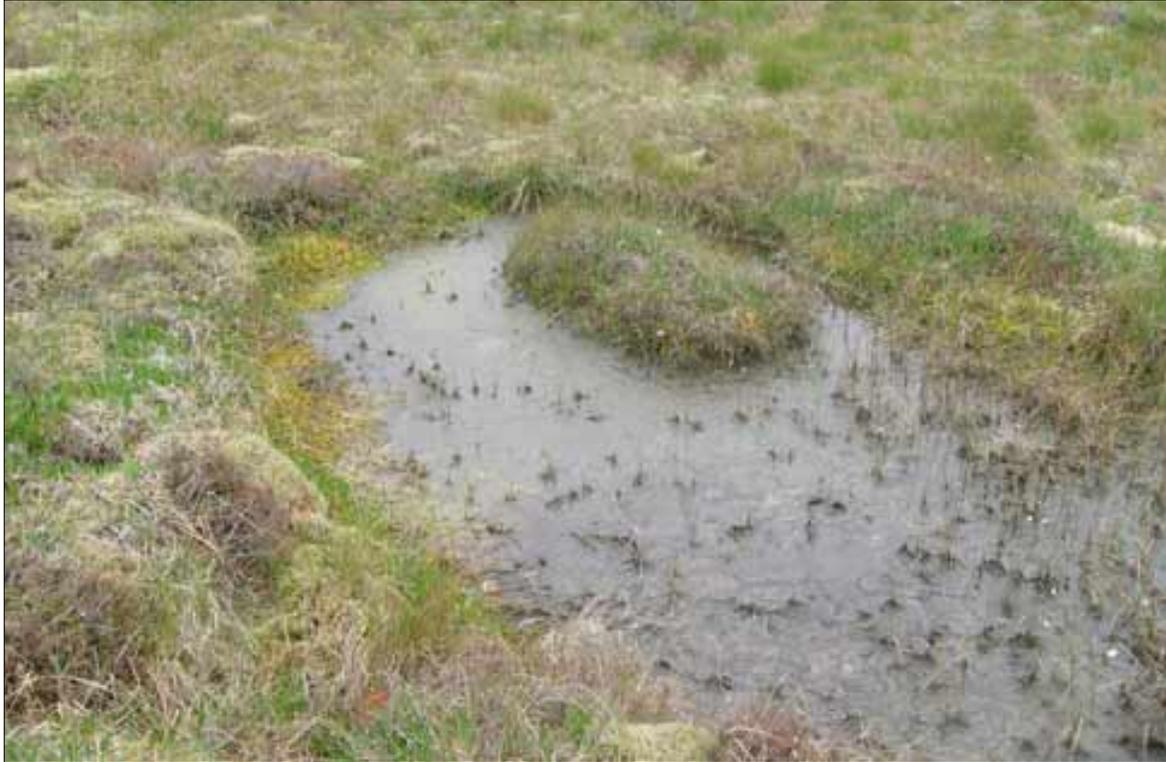
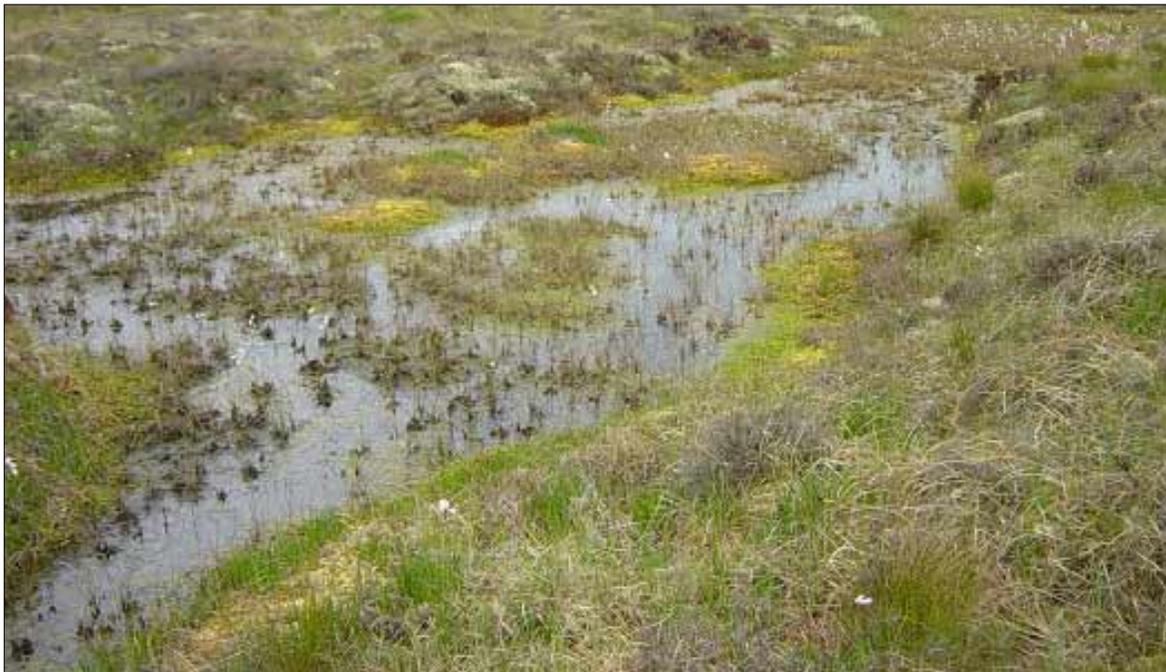
**Plate 2.3:** Example of the only bog pool complex surviving on Cashlaundrumlahan. As might be expected, this indicates an area of deep peat on the summit ridge and represents a watershed mire mesotope with a typical microtope pattern of pools.

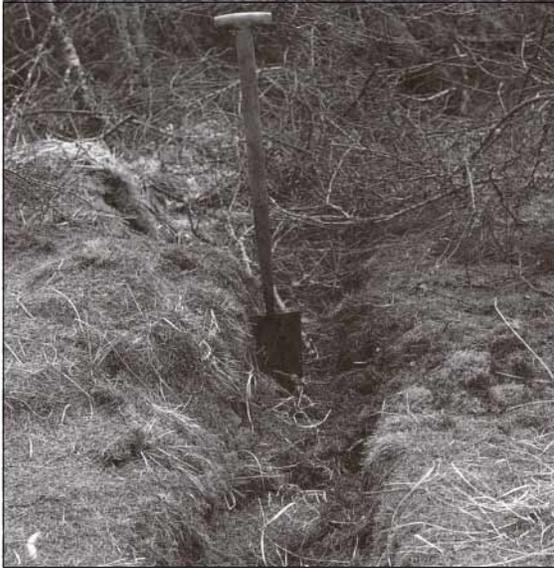
**Plate 3.1: Longitudinal crack in a plough furrow under mature forestry on deep peat in the north of Scotland, after removal of the litter layer.**

Eventually, a point is reached where the peat's resistance to tearing is less than its resistance to subsidence, so it cracks. The ditches and furrows act as lines of weakness to the tensile stress produced by shrinkage of the intervening peat mass. The first cracks appear in summer along deep ditches, where the fibrous acrotelm has been removed and are followed a year or two later by similar cracks in furrows (plate 3.1). These early cracks can appear in very wet soft peat and are usually hidden by the litter and root mat.

Shrinkage cracks are commonly up to 15 cm wide and extend to a depth of 70 cm. Although they form in summer, they persist from year to year because peat shrinkage is irreversible. They do not, however, extend across the forestry rides. The water table lies below the cracked layer during the summer but rises into the cracks in winter. The ditches draining these cracks can lose half their depth within 15 to 20 years and, if they become blocked, the water stands in the cracks. However, once the reticulate network has developed, this can act as a drainage system. Dried peat has a limited ability

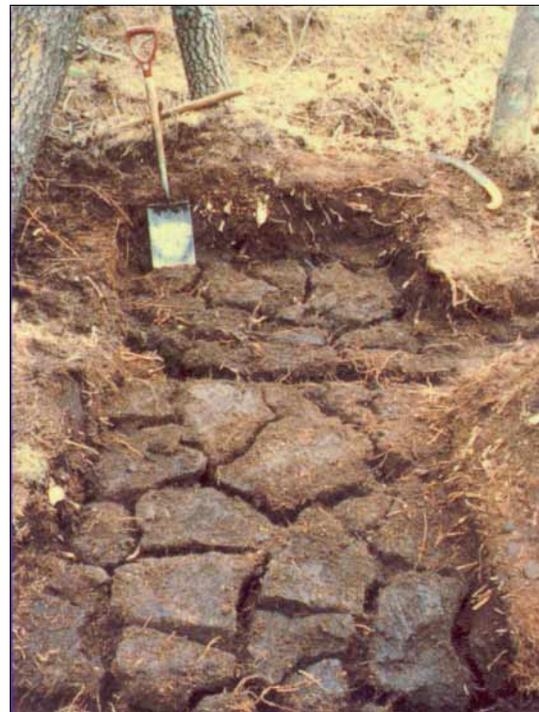
**Plate 3.2: Reticulate cracking in a plough ridge under mature forestry on deep peat in the north of Scotland, revealed by removing the surface fibrous layer.**

Some years later, reticulate networks of cracks develop on the plough ridges directly beneath the trees. These develop fully within 20 years of planting on shallow and moderately deep peats and can penetrate to the substratum if the peat layer is less than one metre thick. These cracks are confined to the catotelm peat which has by now lost a great deal of water and is fairly dense. They do not open on the surface because the acrotelm is reinforced by strong structural tree roots but are invariably found when the surface 30 cm fibrous layer is removed (plate 3.2). However, the ditch and furrow cracks now become visible because they have grown so wide that the root and litter mat tears (fig 3.1).

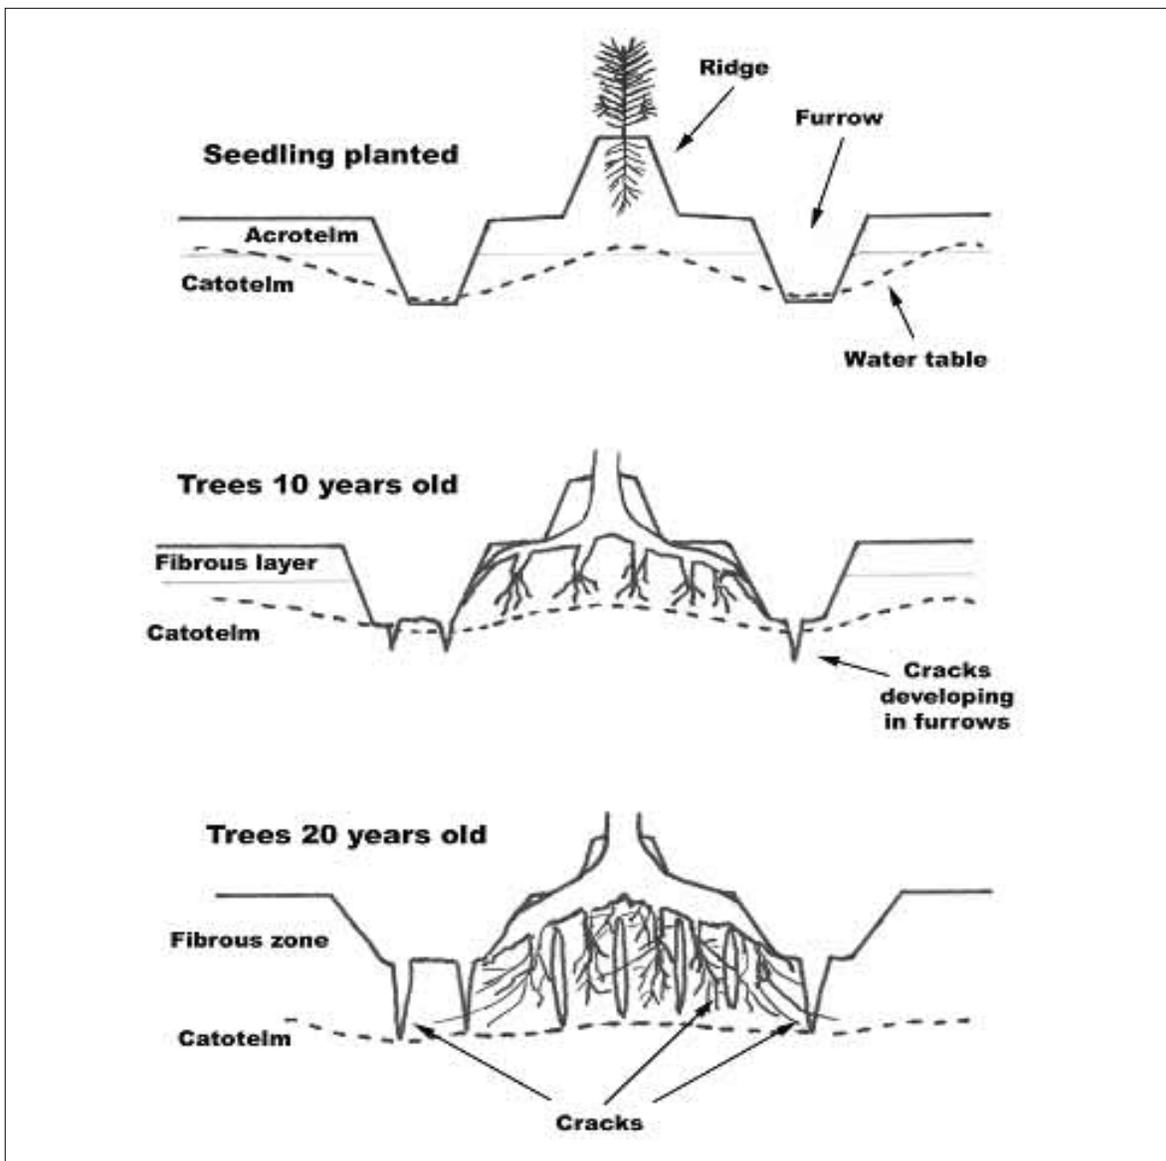
Figure 3.1: The sequence of drying and cracking that occurs in peat over a 20-year period beneath plantation forestry, particularly when the crop is lodgepole pine, *Pinus contorta* (adapted from Pyatt 1987).

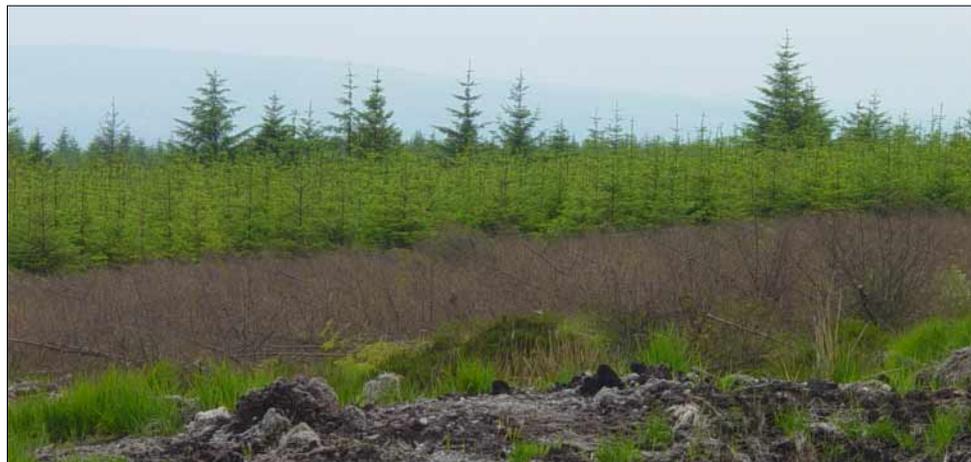
**Plate 3.3:** Spruce planted after the south-west part of the forest was destroyed by fire about 10 years ago. The ground here has thus been drained and planted twice: part of this area was involved in the October 2003 bog slide.

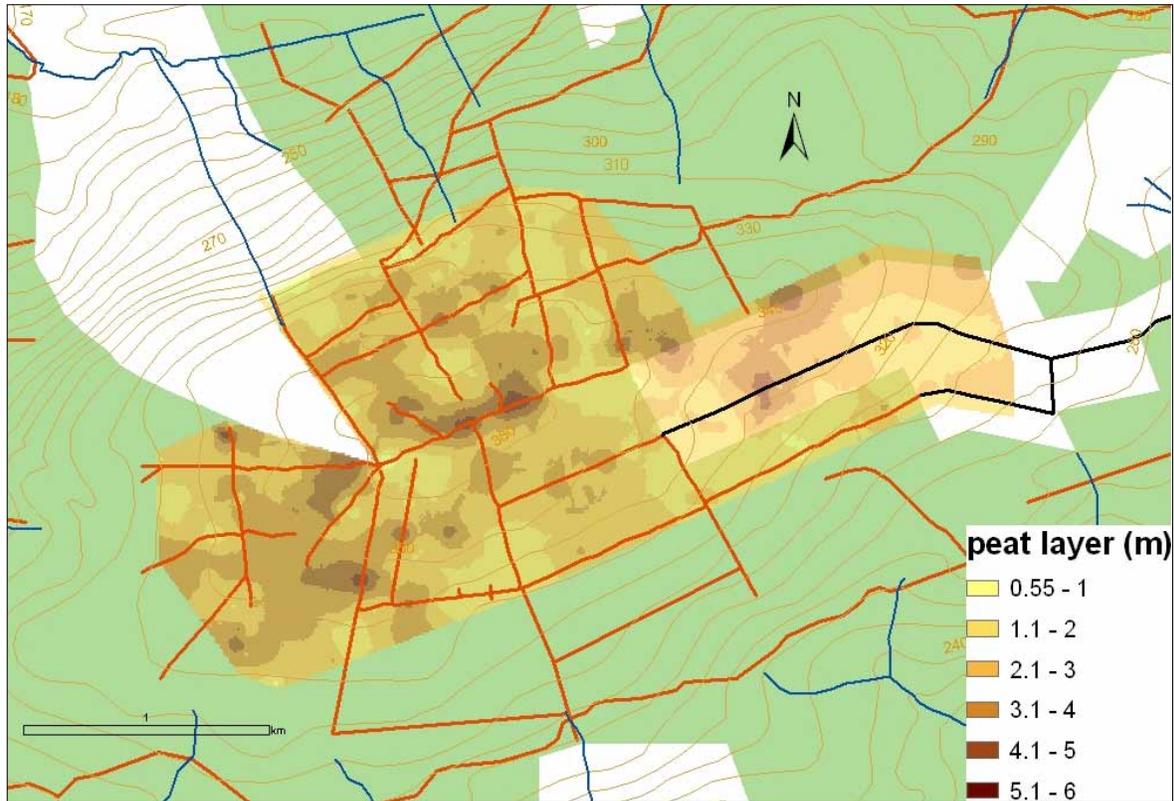
**Figure 3.3:** The turbary road (black) and forestry rides (orange) on the site. Forestry areas are shaded green. The wind-farm boundary is indicated by the area for which peat thicknesses are shown, streams are shown in blue.

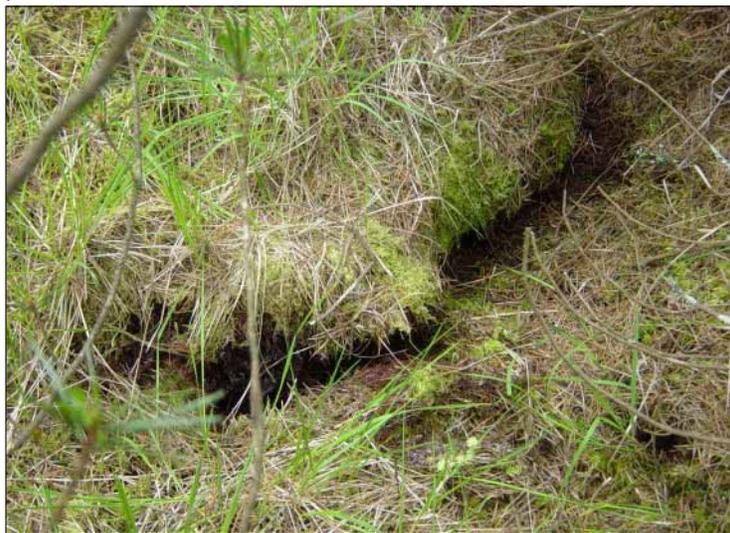
**Plate 3.4:** A crack in the peat surface beneath forestry which is just visible despite the thick litter layer.

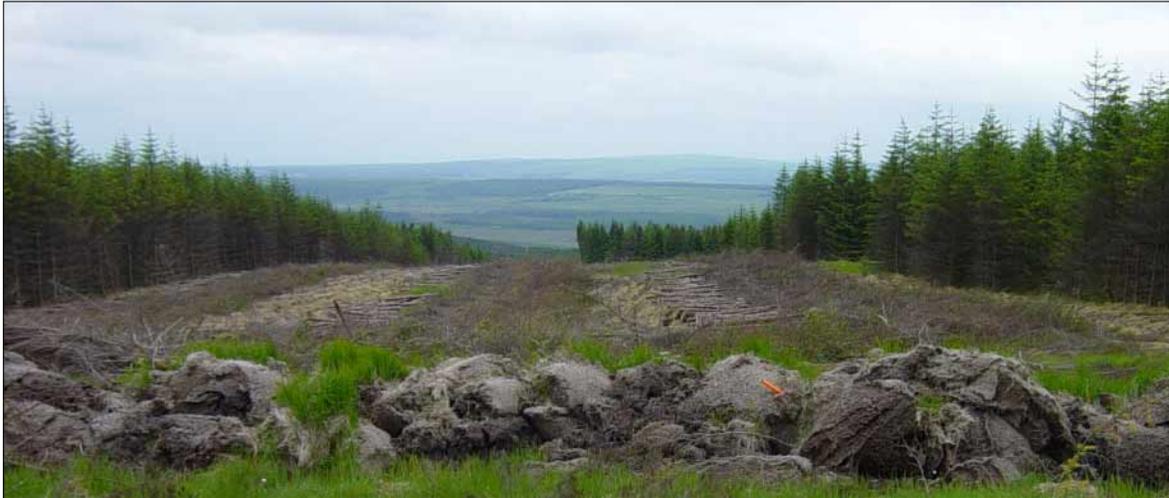
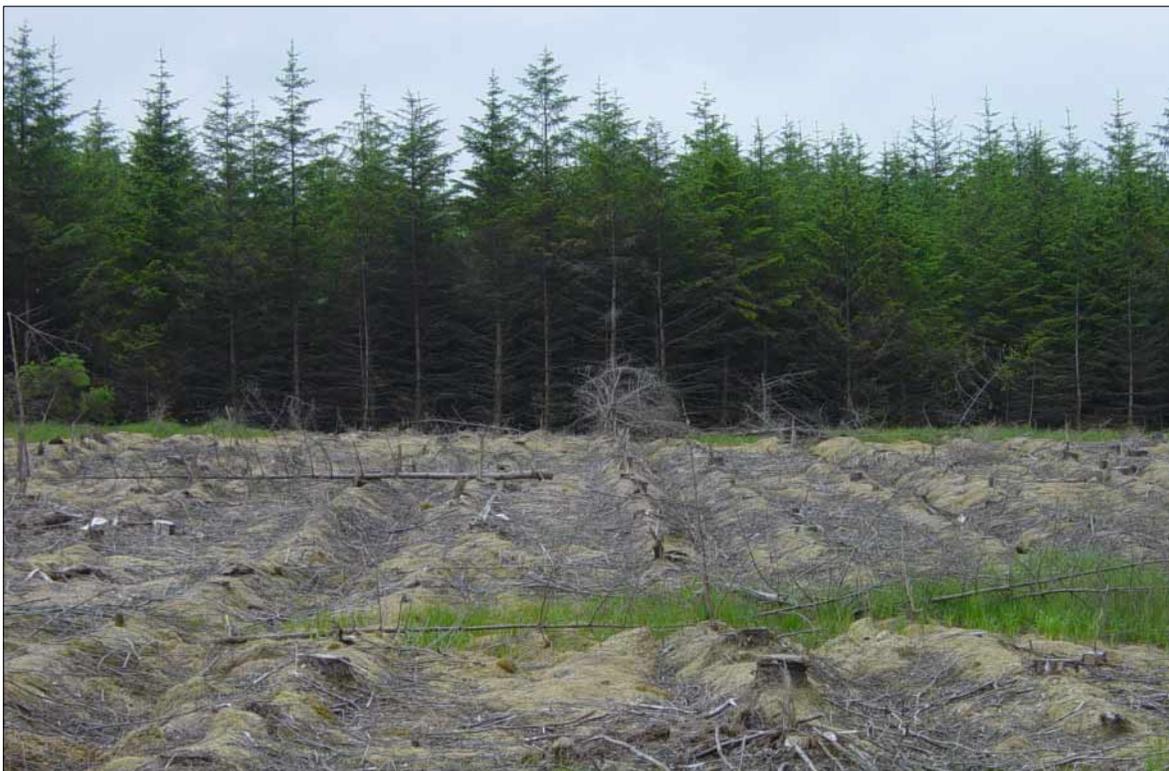
**Plates 3.5: Areas on Cashlaundrumlahan where forestry has been felled to make way for construction work.**

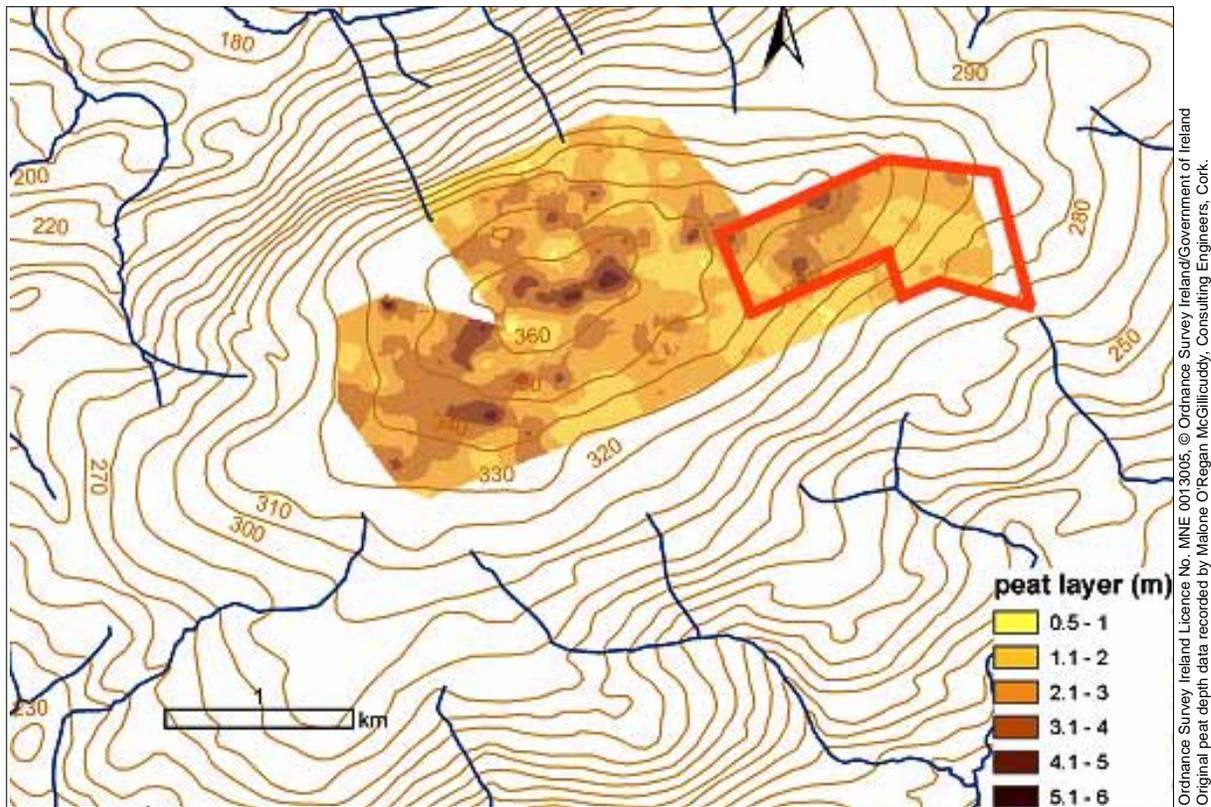
**Figure 3.4:** The extent of the turbary (indicated by the red boundary) on the Cashlaundrumlahan summit. The wind farm boundary is indicated by the area for which peat thicknesses are given.

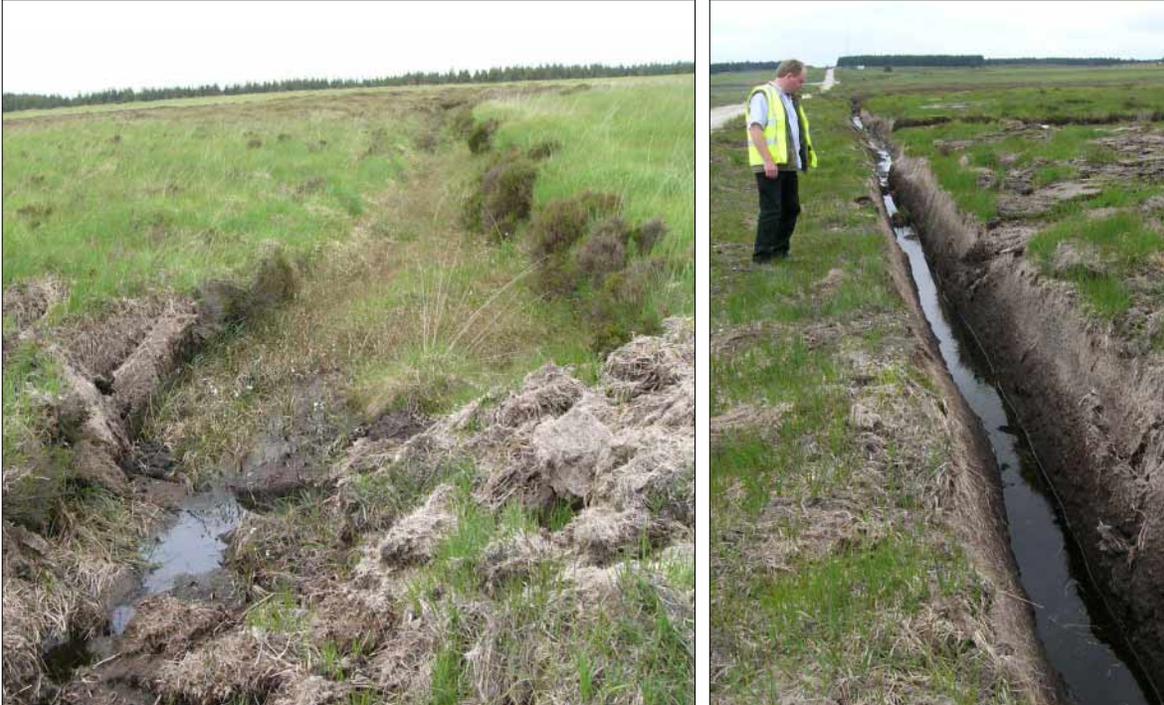
**Plate 3.6:** Turbarry fields on the summit of the site showing (above) an old peat bank and (right) the downslope catchwater drainage system, re-excavated after peat slide in 2003).

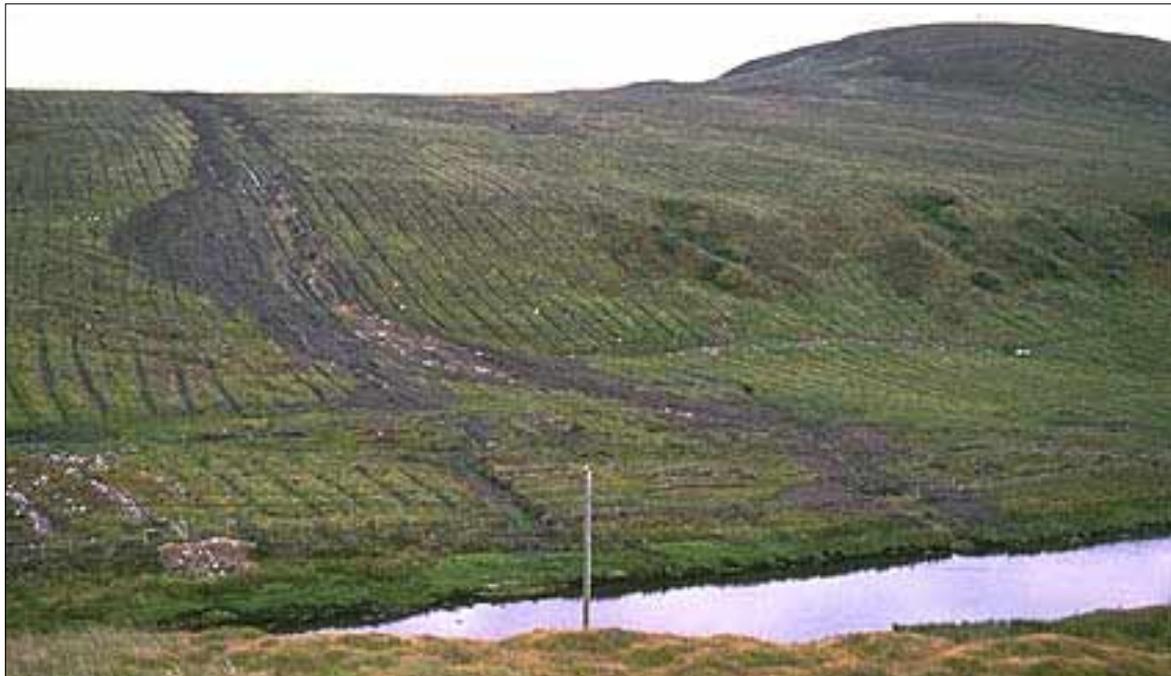
**Plate 4.1: A bog burst in pre-drained forestry area in Co. Mayo blanket bog. Liquefied peat was discharged into the Owenmore River. Late 1980s.**

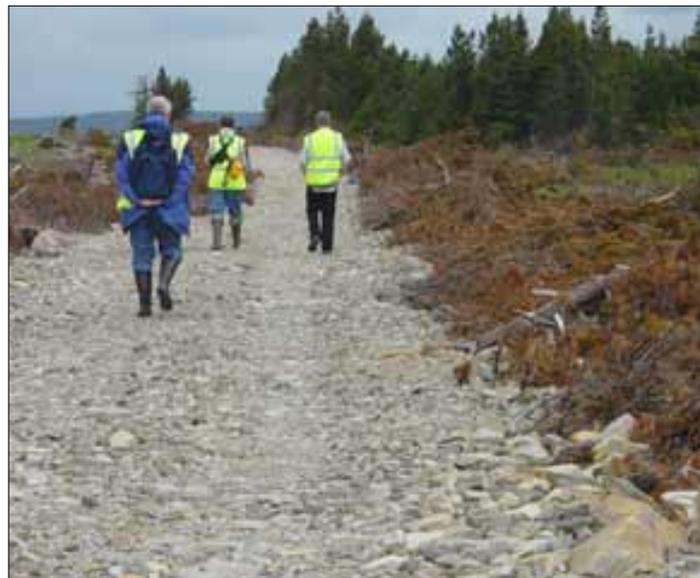
**Plate 5.1: Floating road at Derrybrien Wind Farm.**

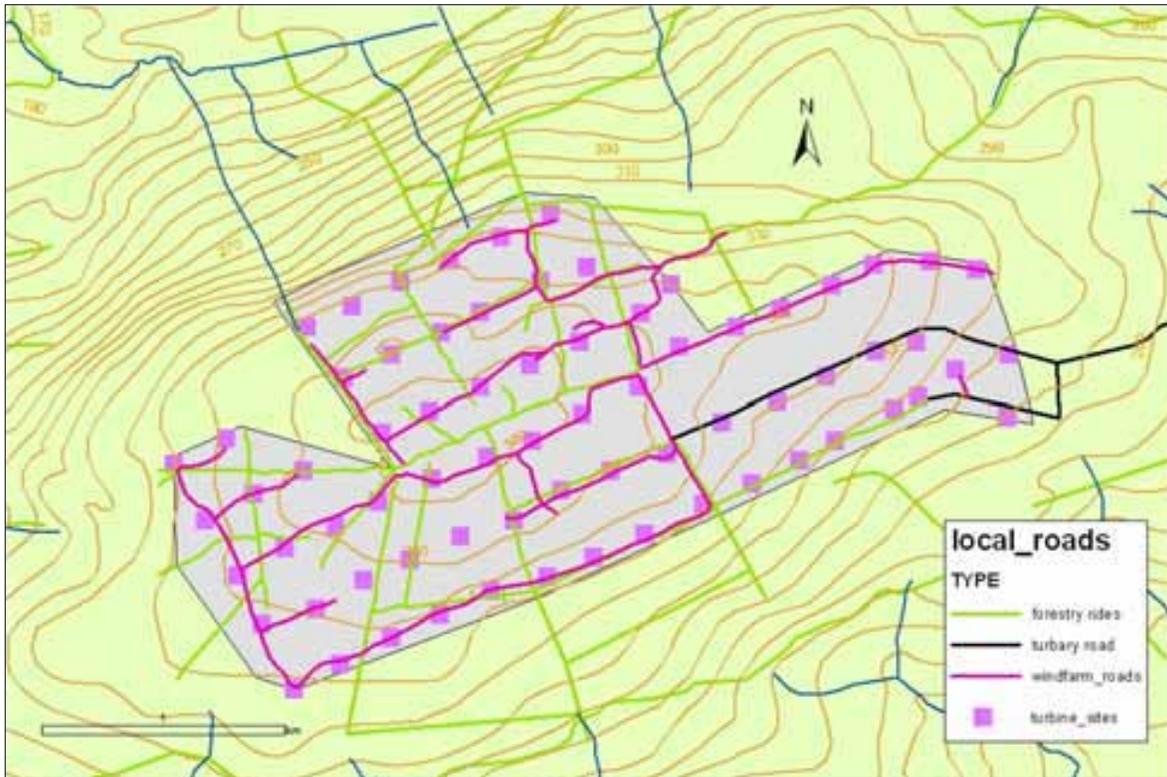
**Figure 5.2:** Arrangement of existing turbarry road (black) and forest rides (green) on the Derrybrien site together with the new floating roads (purple) built before October 2003. (New roads according to AGEC 2004.) Some of the turbine sites (lilac squares) are not yet served by access roads so that a need for further road construction can be anticipated. Stream-courses are shown in blue, contours in pale brown.

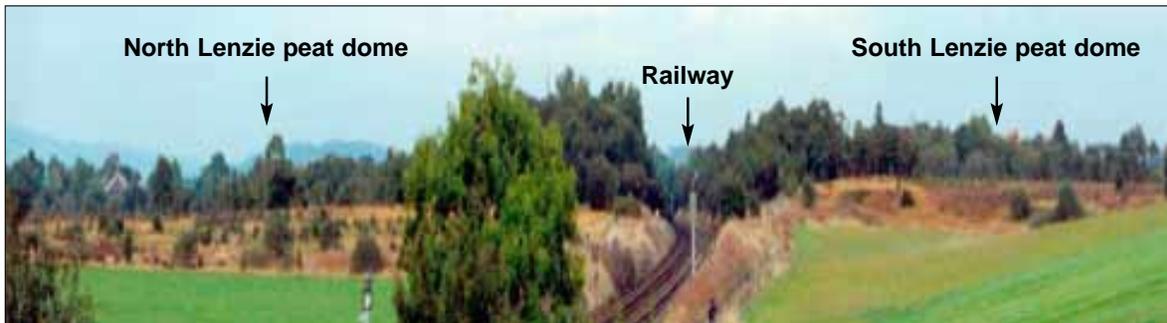
**Plate 5.2:** Railway line ‘floated’ across Lenzie Moss during the 19th Century. The track has now sunk by about three metres and the bog is clearly divided into two sections. Note also the lines of taller trees flanking the track, reflecting the associated drainage.

There are many examples of ‘floating’ roads or railways from Britain and Ireland and plate 5.2 shows one on Lenzie Moss in Scotland. Here, a railway line that was floated across the bog in the 19th century now lies at the base of a three-metre cutting. It is evident that, in practice, even when a road or railway is constructed using the floating principle, it very rarely truly floats on the mire surface but tends instead to sink deeper and deeper into the peat, in some cases very obviously so, as at Lenzie Moss. Here it has sunk to a much greater depth than can be explained by simple waterlogging of the underlying raft.

wooden boat does not sink simply because it has been floating on the water for some time. The floating-road design becomes less attractive, however, when we realise that a timber raft will eventually become waterlogged and that wet wood is negatively buoyant. Even a soundly-made boat requires constant maintenance if the timbers are not to become waterlogged. If they do, the boat will sink just like any other waterlogged timber. A road built to a design based on floating timber cannot be expected to float for very long. Once it ceases to float, the wood and the aggregate on top of it will begin to sink into and/or compress the peat beneath.

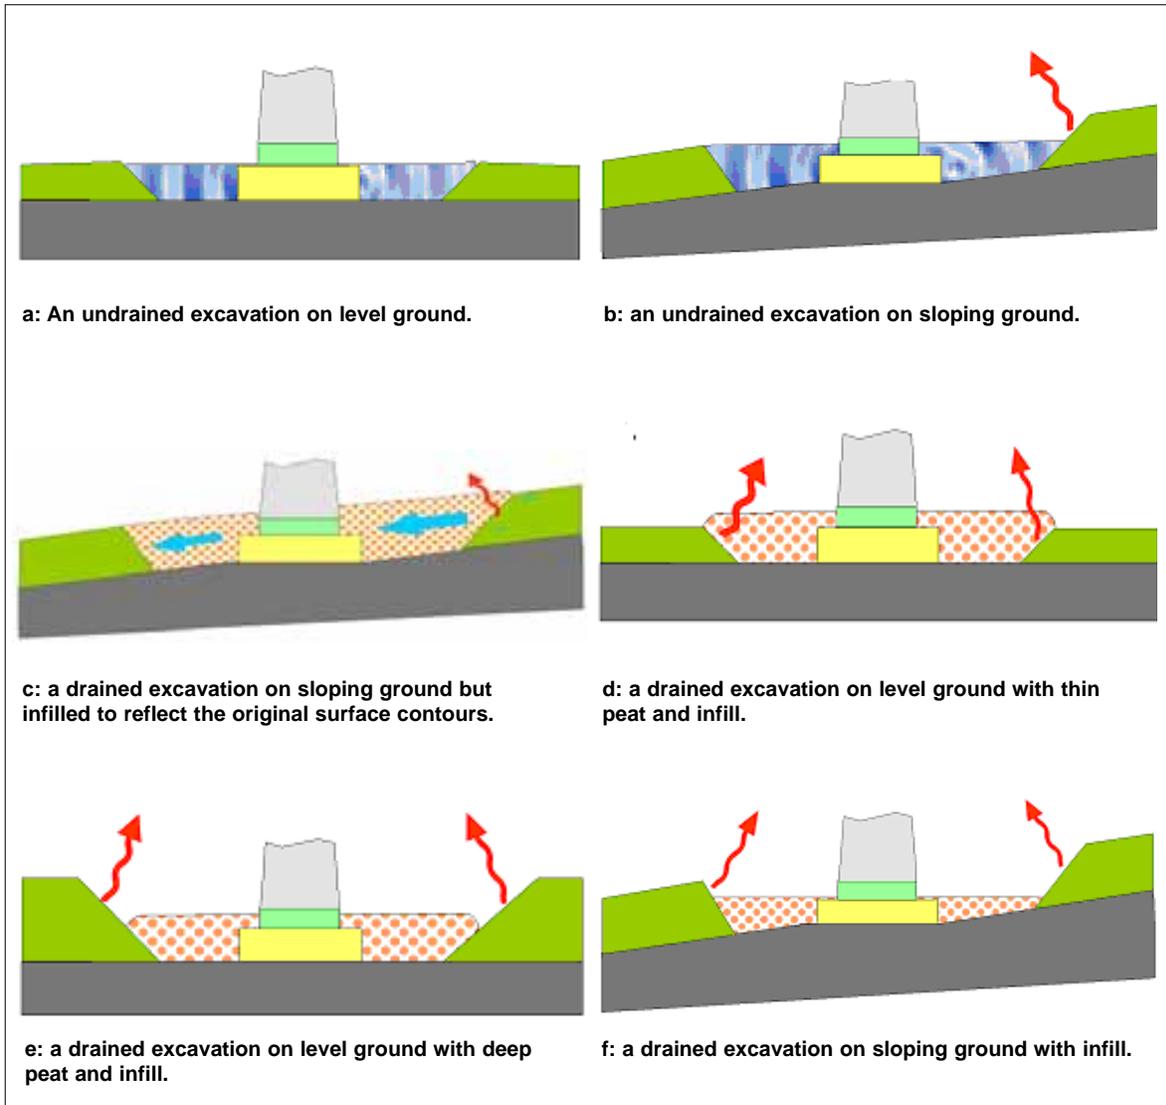
Figure 5.3: Turbine-base construction. The illustrations represent a cross-section of an excavation and construction for a wind-turbine tower. The bedrock is dark grey, the peat thickness is green, water is blue and rock infill is red spots. The yellow is the concrete base for the turbine, the turquoise is the turbine base 'can' and the light grey is the turbine tower. The red wavy arrows represent loss of CO<sub>2</sub> and water from the peat, the blue arrows represent water movement.

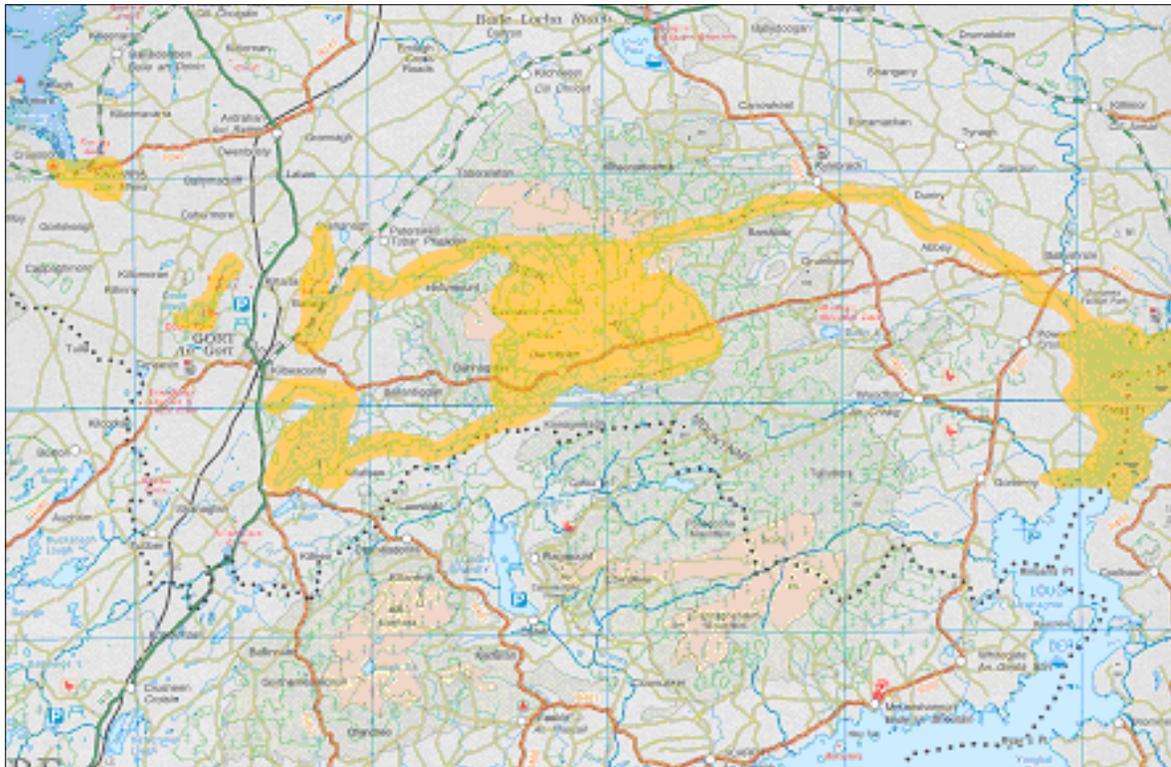
**Figure 6.3:** A map showing the total area (shaded orange) that might be affected by wind farm development on Cashlaundrumlahan and which should thus form part of the EIA process. Parts of the catchment drainage systems are connected through underground karst systems and are thus not easy to follow along their whole length.

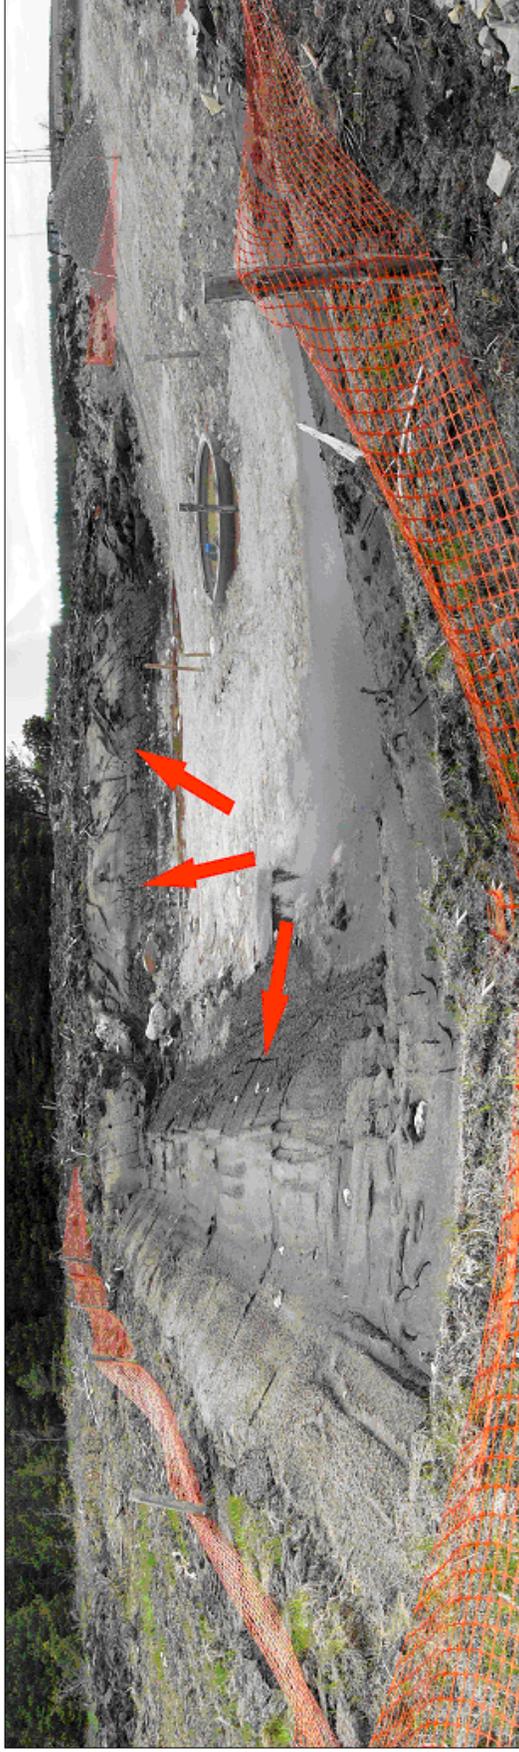
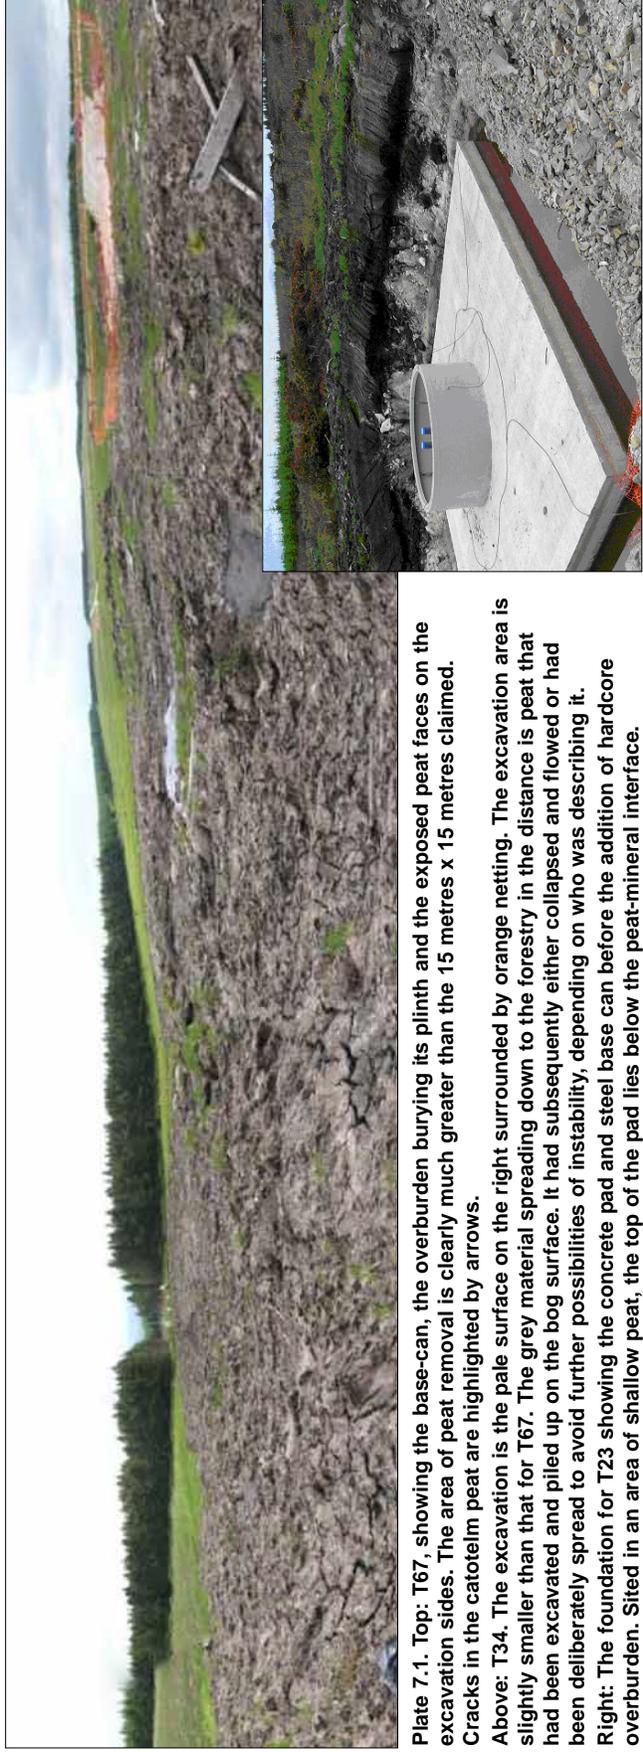
Plate 7.1. Top: T67, showing the base-can, the overburden burying its plinth and the exposed peat faces on the excavation sides. The area of peat removal is clearly much greater than the 15 metres x 15 metres claimed. Cracks in the catotelm peat are highlighted by arrows.  
 Above: T34. The excavation is the pale surface on the right surrounded by orange netting. The excavation area is slightly smaller than that for T67. The grey material spreading down to the forestry in the distance is peat that had been excavated and piled up on the bog surface. It had subsequently either collapsed and flowed or had been deliberately spread to avoid further possibilities of instability, depending on who was describing it.  
 Right: The foundation for T23 showing the concrete pad and steel base can before the addition of hardcore overburden. Sited in an area of shallow peat, the top of the pad lies below the peat-mineral interface.

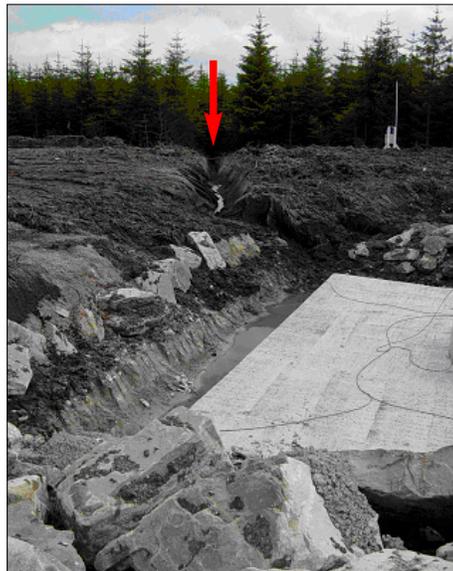
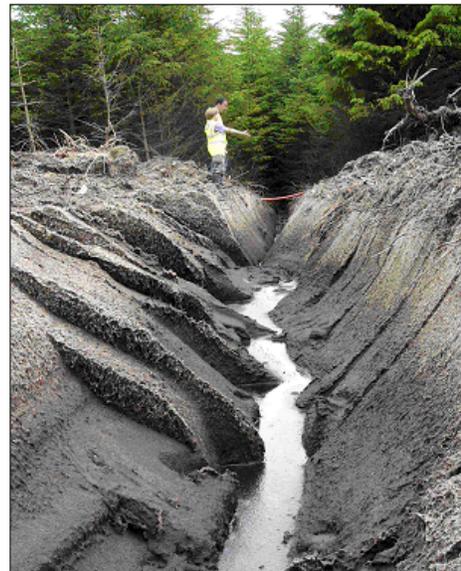
**Plate 7.2: A drain dug to release water from the base of turbine T2. Note the rock reinforcement required to stabilise the sides of the excavation.**
