# Wind farms and blanket peat

a report on the Derrybrien bog slide

**The Bog Slide of 16th October 2003  
at Derrybrien, Co. Galway, Ireland**

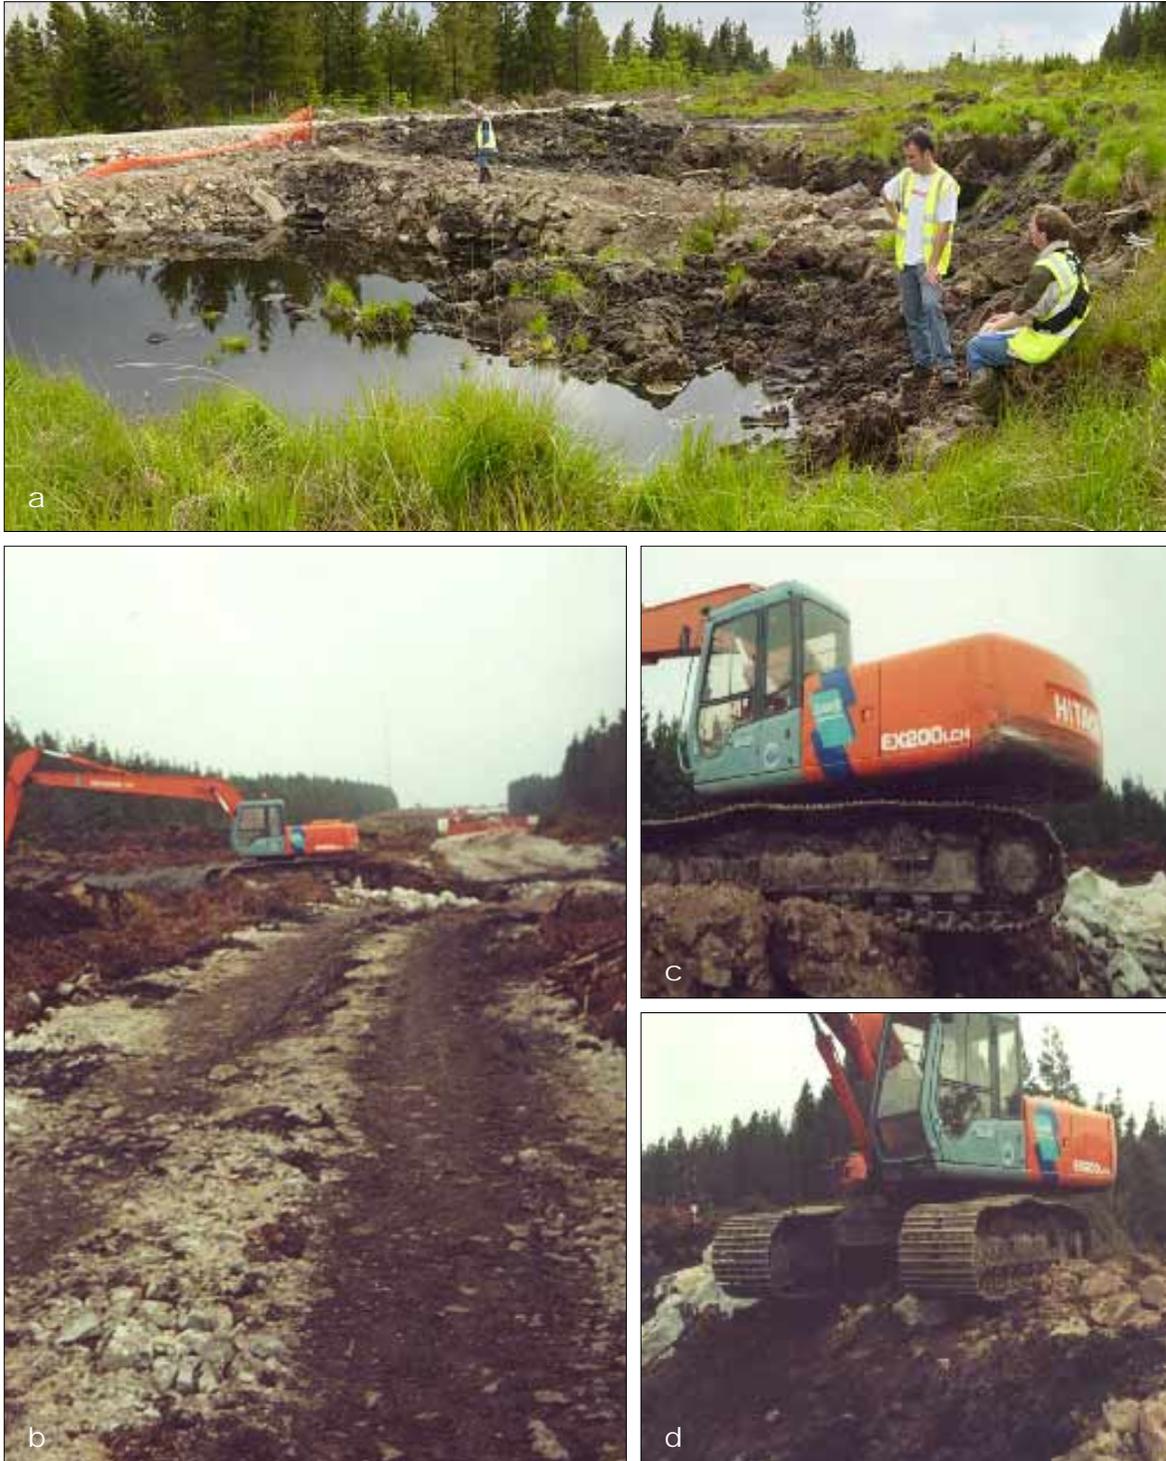
**Plate 8.2: The head of the peat slide at T68. a: turbine base excavation in June 2004; b: deformation of floating road October 2003; c, d: an excavator after the bog slide.**

Plates 8.2 to 8.5 give a photographic record of the section of the failure scar that lies within the wind farm boundary. The excavation at T68 was reported not to have failed and indeed appeared still to be more or less intact in June 2004 (plate 8.4a). The head of the failure was coincident with the upslope edge of a site access road a few metres downslope of the excavation. Photographs taken

within days of the slide indicate that the southern wall of the excavation remained in place, supporting a precariously perched excavator. The road had bowed southwards by 10-20 metres (plates 8.2b, c and d). Plate 8.3, taken in June 2004, gives two views looking southwards from the reconstructed road at T68. The pattern of detachment of rafts of vegetation along plough lines was still evident in mature lodgepole pine plantation at the eastern side of the scar. South of T70, a small exposure of bedrock was found at this time (plate 8.4c) but appeared to be the result of water erosion subsequent to the landslide. The trees in this area were smaller than those upslope and included some Sitka spruce understood to have been planted to repair fire damage (plate 8.4a). A crack in apparently intact surface was found at the eastern edge

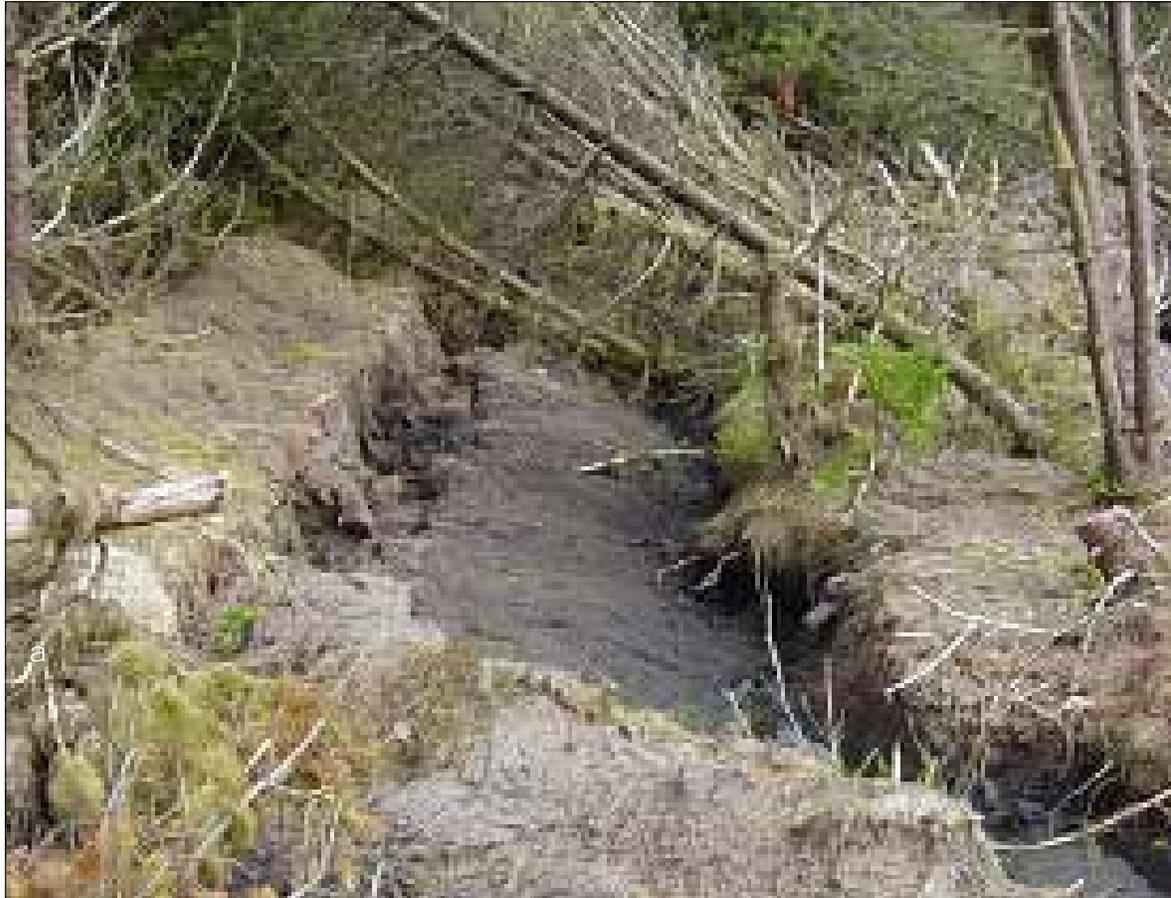
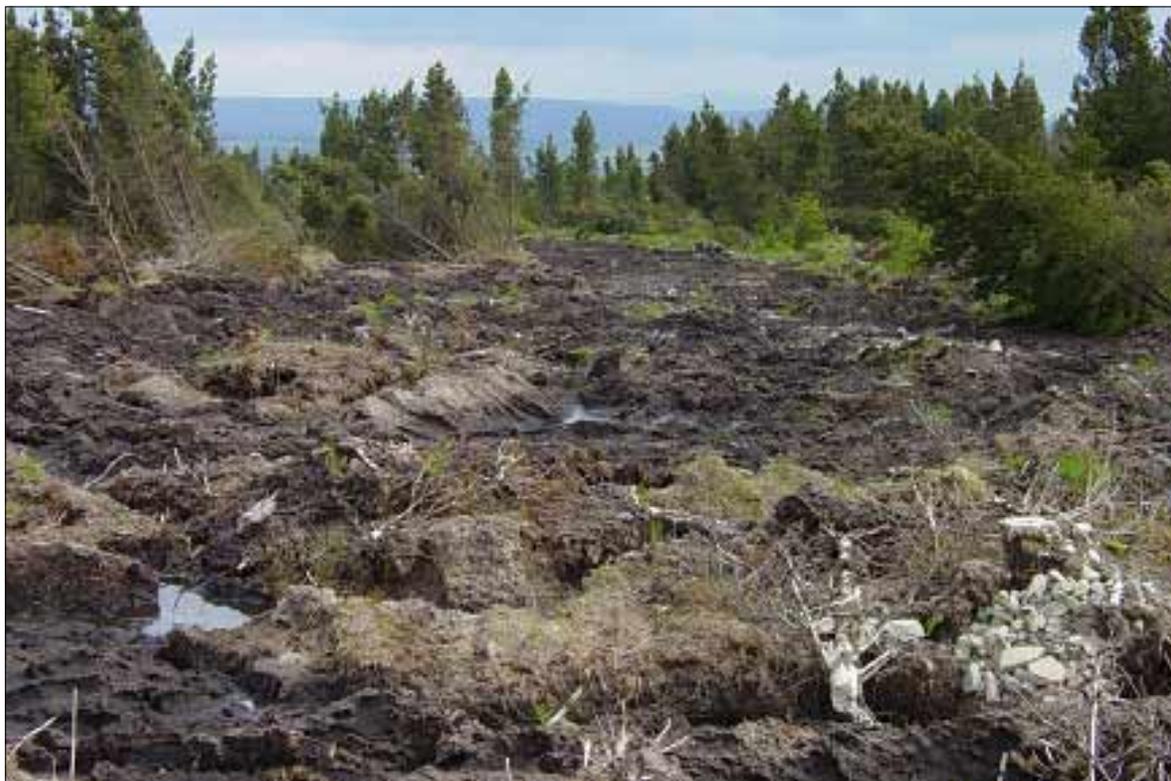
Plate 8.3: The bog slide just below T68, 8 June 2004. Top, the pattern of detachment of rafts of surface vegetation along forestry plough lines at the west side of slide and, bottom, the centre of the slide, looking south.

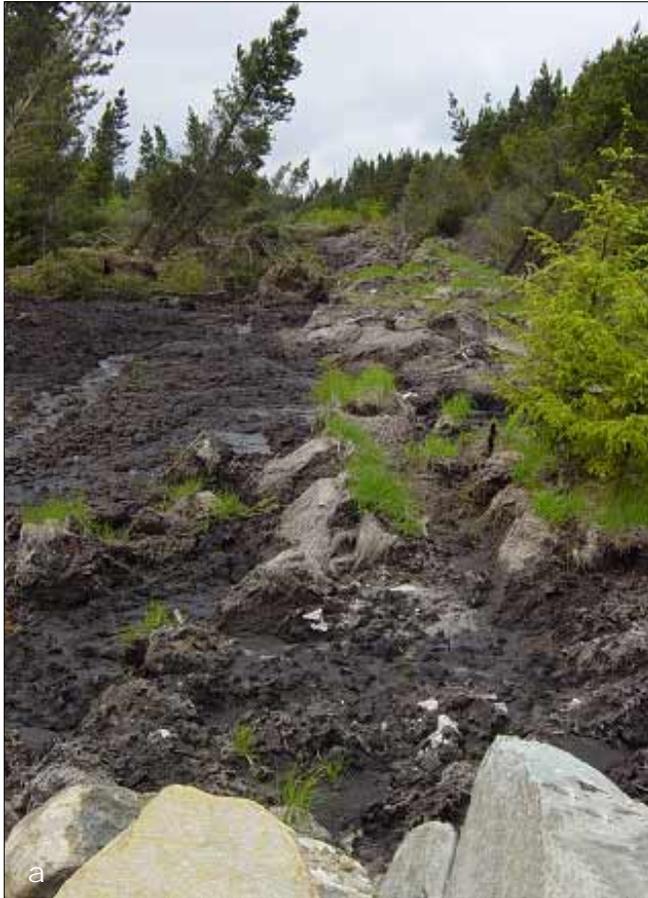
Plate 8.4. Site T70 on 8 June 2004.  
a: looking upslope from road towards T68;  
b: looking upslope towards T70;  
c: exposure of the bedrock.

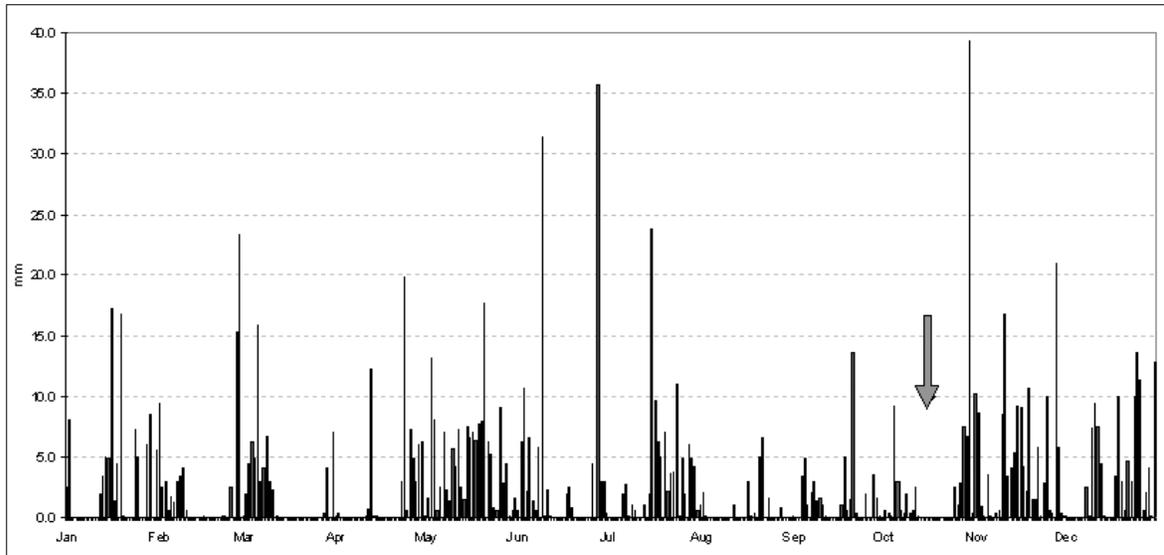
Figure 8.2: Daily rainfall for Derrybrien during 2003. The arrow indicates the date of the bog slide.

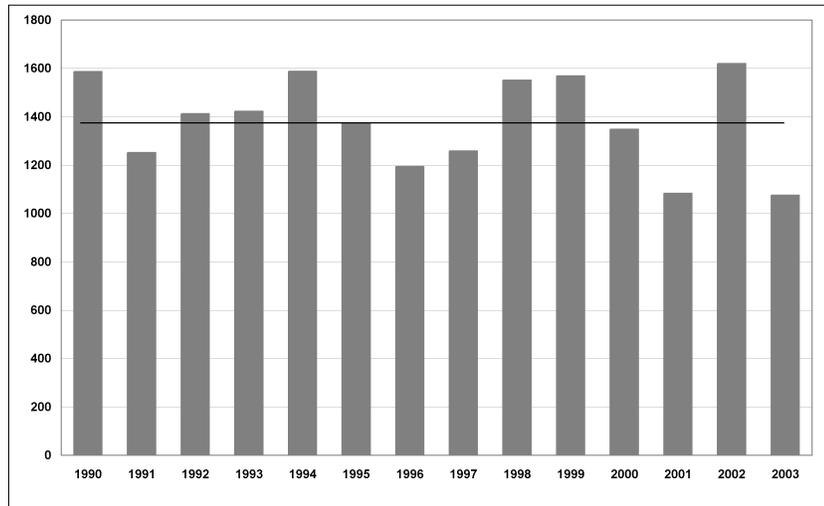
Figure 8.3: Annual (vertical bars) and 14-year annual mean (horizontal line) rainfall for Derrybrien, 1990 to 2003.

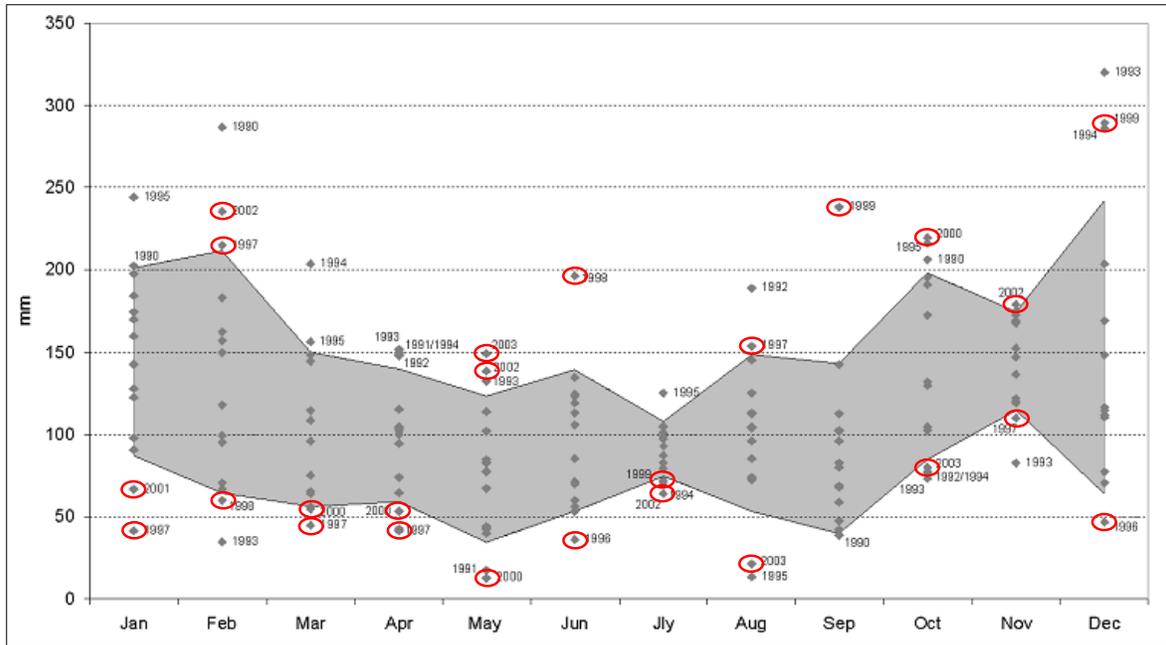
**Figure 8.4: The range of monthly rainfall totals at Derrybrien, 1990 to 2003. The labelled values lie more than one standard deviation above or below the monthly mean (the shaded envelope) and are taken to indicate ‘high-’ and ‘low-rainfall’ months respectively. Values for 1996 to 2003 are circled in red and the full dataset is given in table 8.2.**

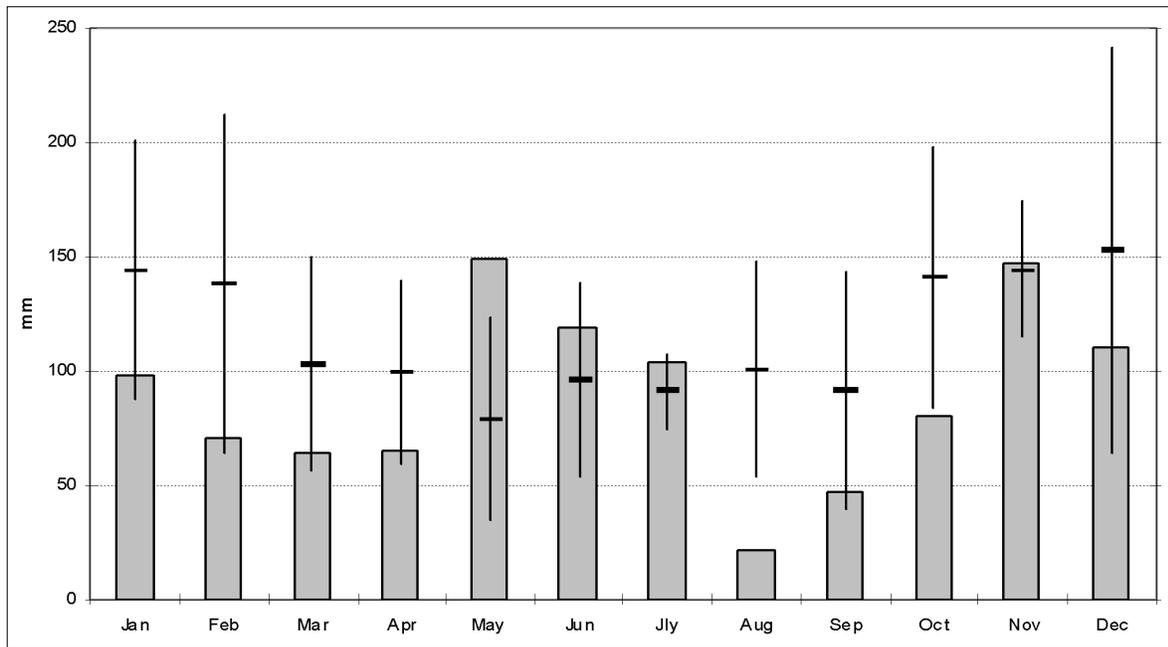
**Figure 8.5: Comparison of Derrybrien monthly rainfall totals for 2003 (grey bars) with 14-year monthly means (black horizontal bars) and standard deviations (black vertical bars).**

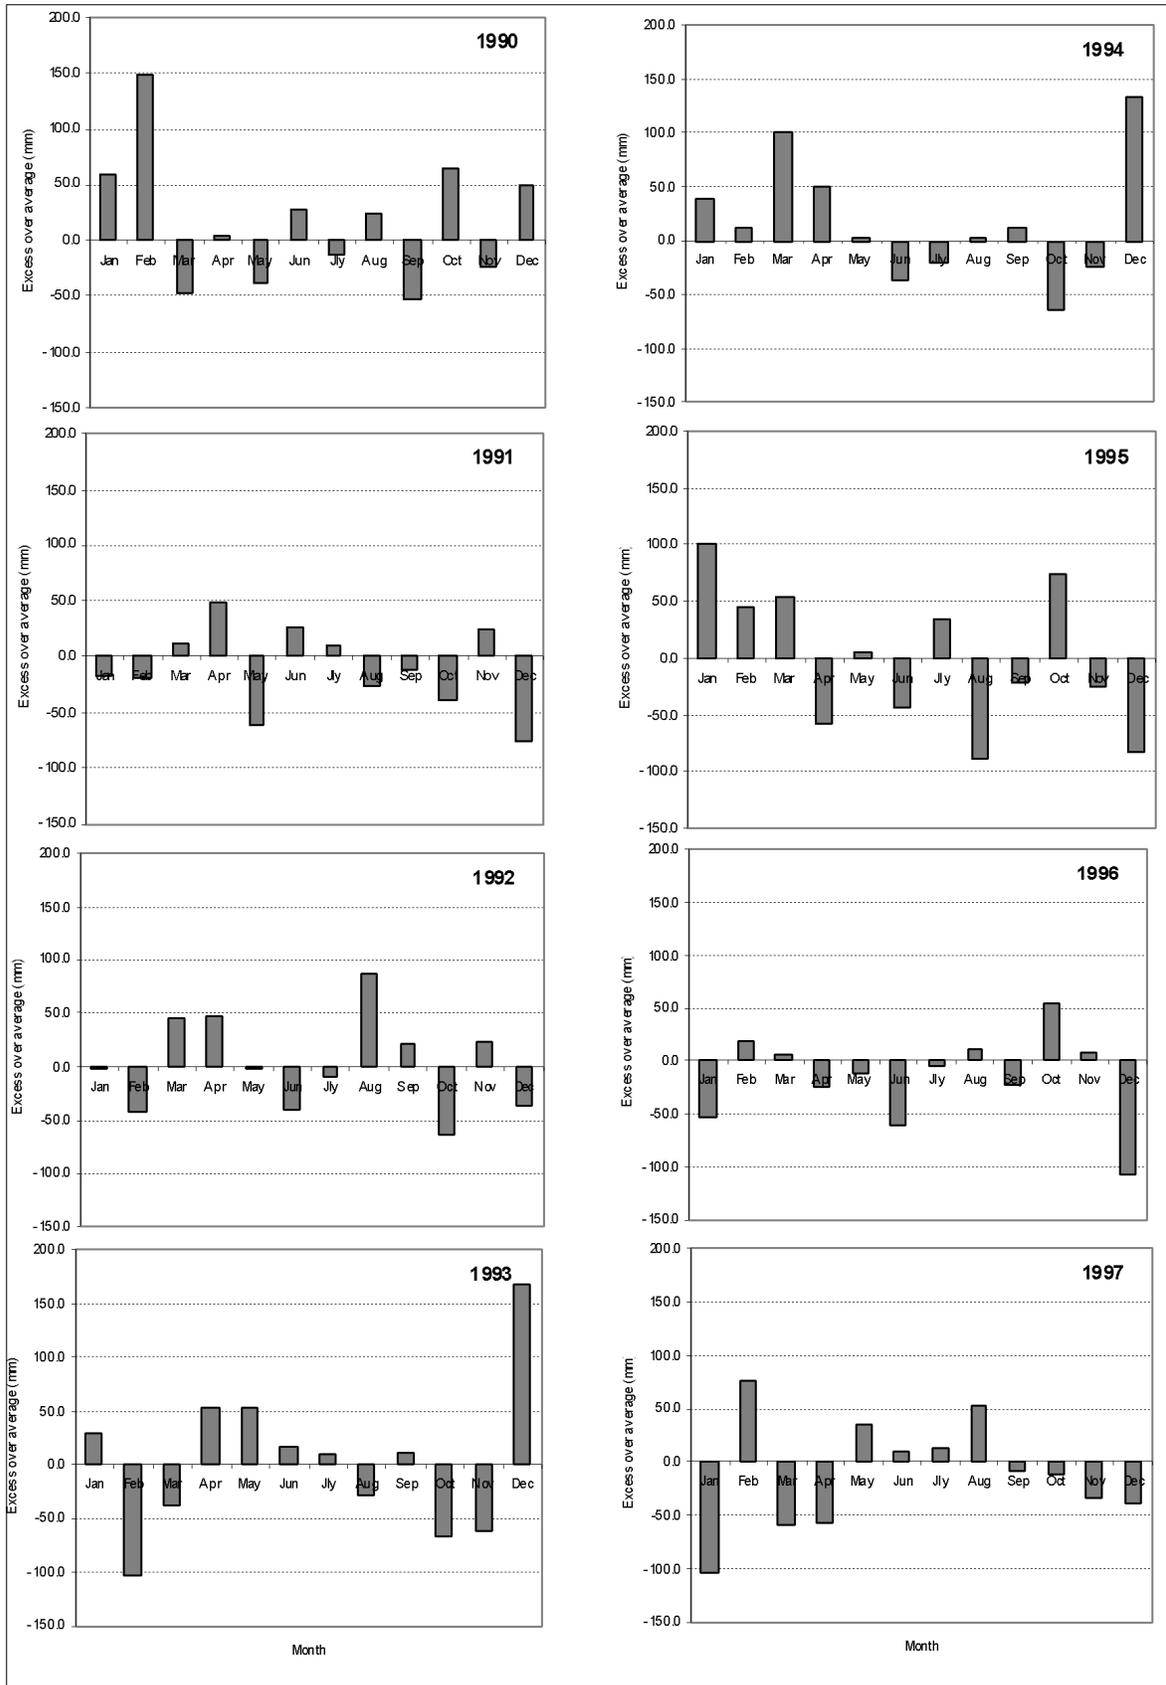
Figure 8.6: Monthly rainfall data for Derrybrien, 1990 to 1997. Each bar indicates the deviation of the month's rainfall total from the appropriate 14-year monthly mean.

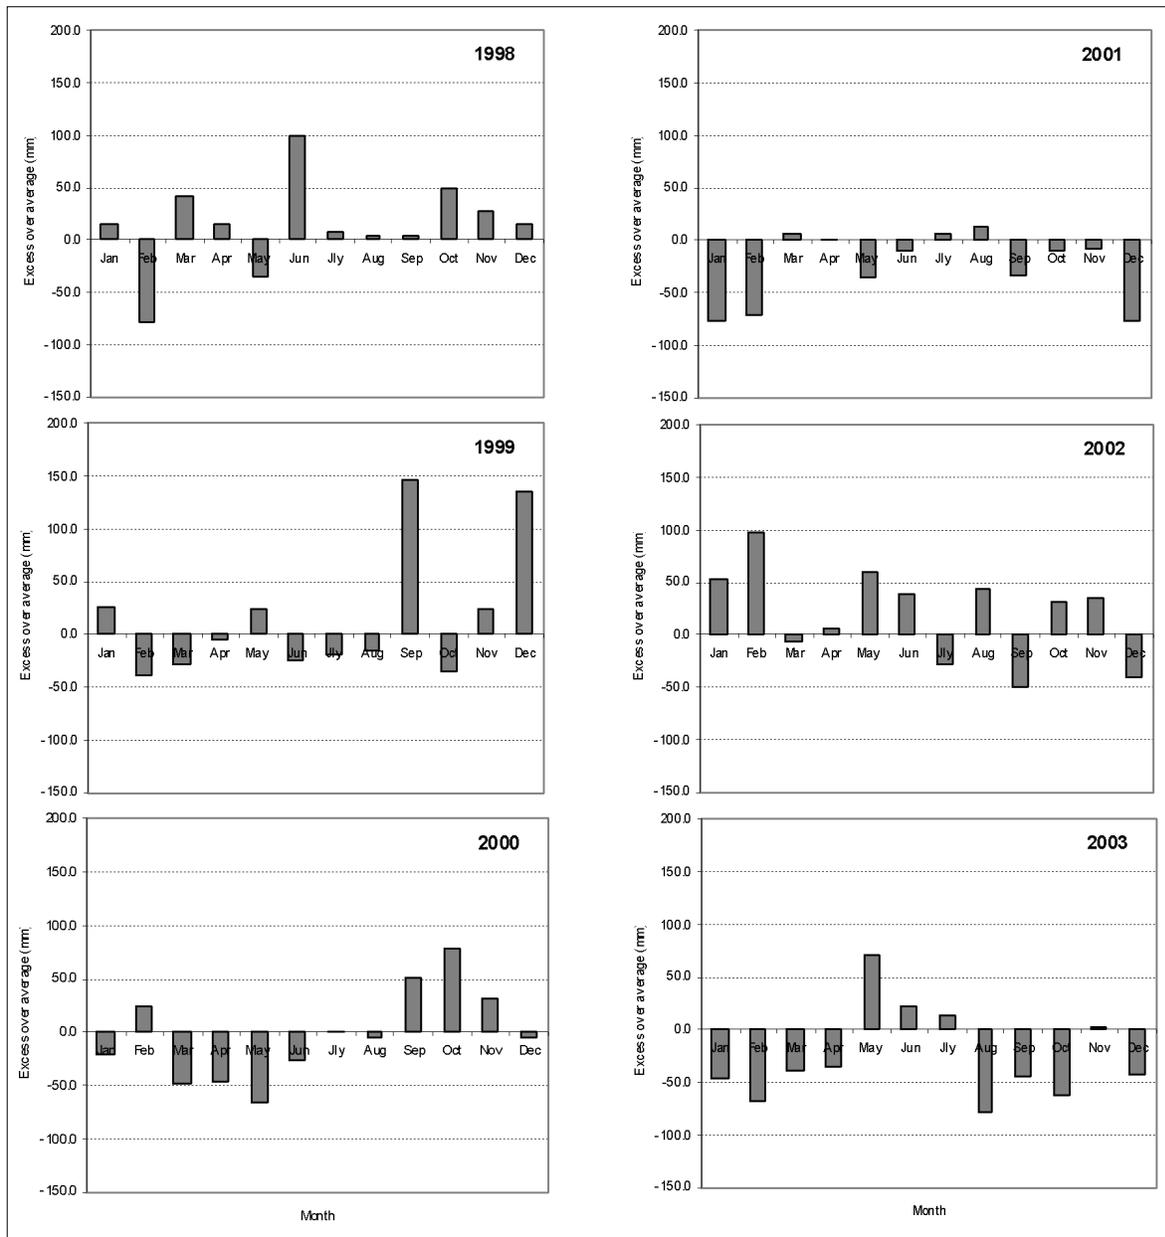
**Figure 8.7: Monthly rainfall data for Derrybrien, 1998 to 2003. Each bar indicates the deviation of the month's rainfall total from the appropriate 14-year monthly mean.**

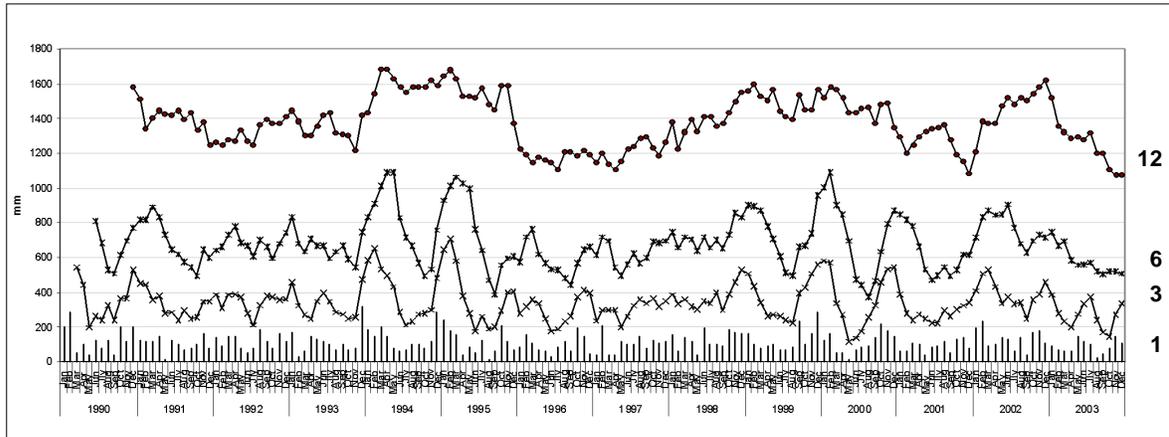
**Figure 8.8: Monthly rainfall totals for Derrybrien, January 1990 to December 2003. The vertical bars at the bottom of the diagram (labelled 1) indicate monthly rainfall totals. The continuous lines indicate the total accumulated rainfall for the three, six and twelve months respectively preceding the last day of each month.**

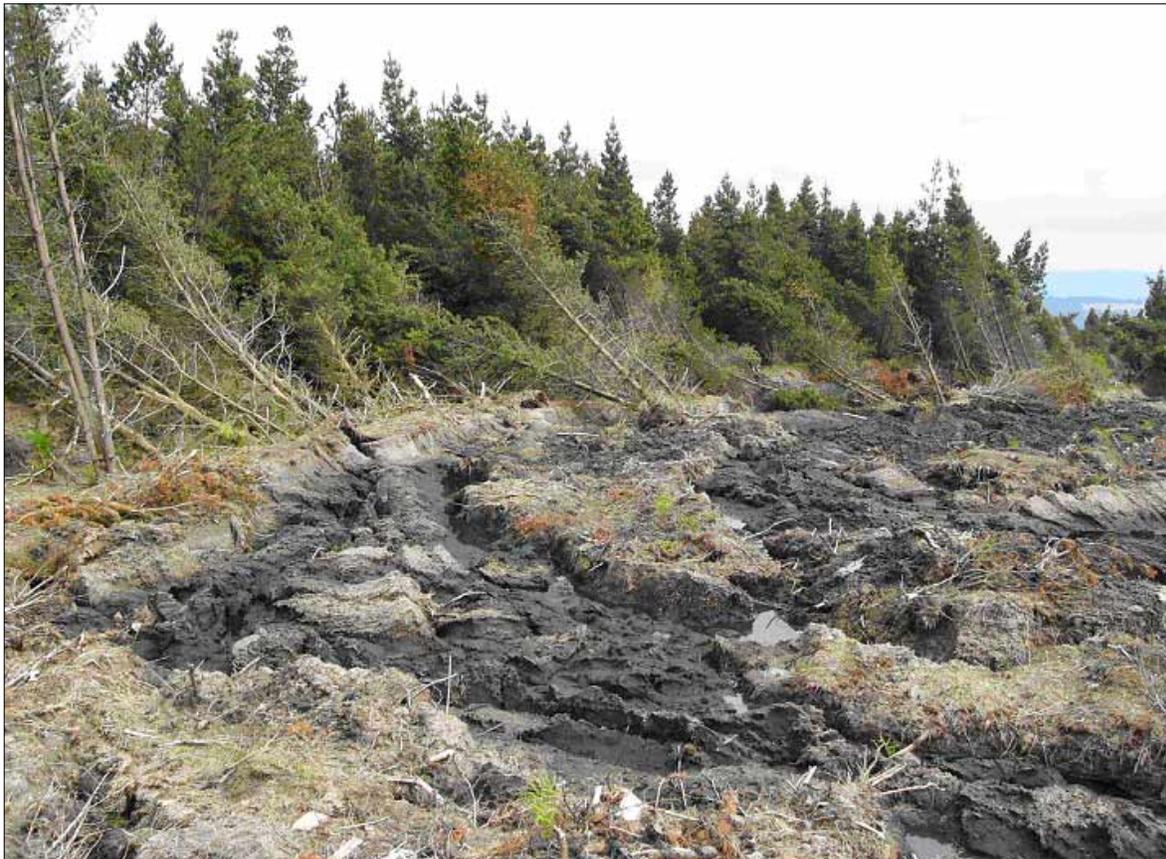
**Plate 8.5:** Looking southwards from T68 on 8 June 2004, the peat appeared to have separated from the plantation along plough furrows to form long ribbons that were progressively drawn into the slide.

The evidence suggests that the failure may have resulted either from loading by excavation machinery or from the release of water into heavily-fissured peat or both. The initial failure led to a series of peat 'ribbons' separating from each other like zips and flowing off downslope, each supporting a line of plantation trees. The fault-lines corresponded to cracks from the forestry.

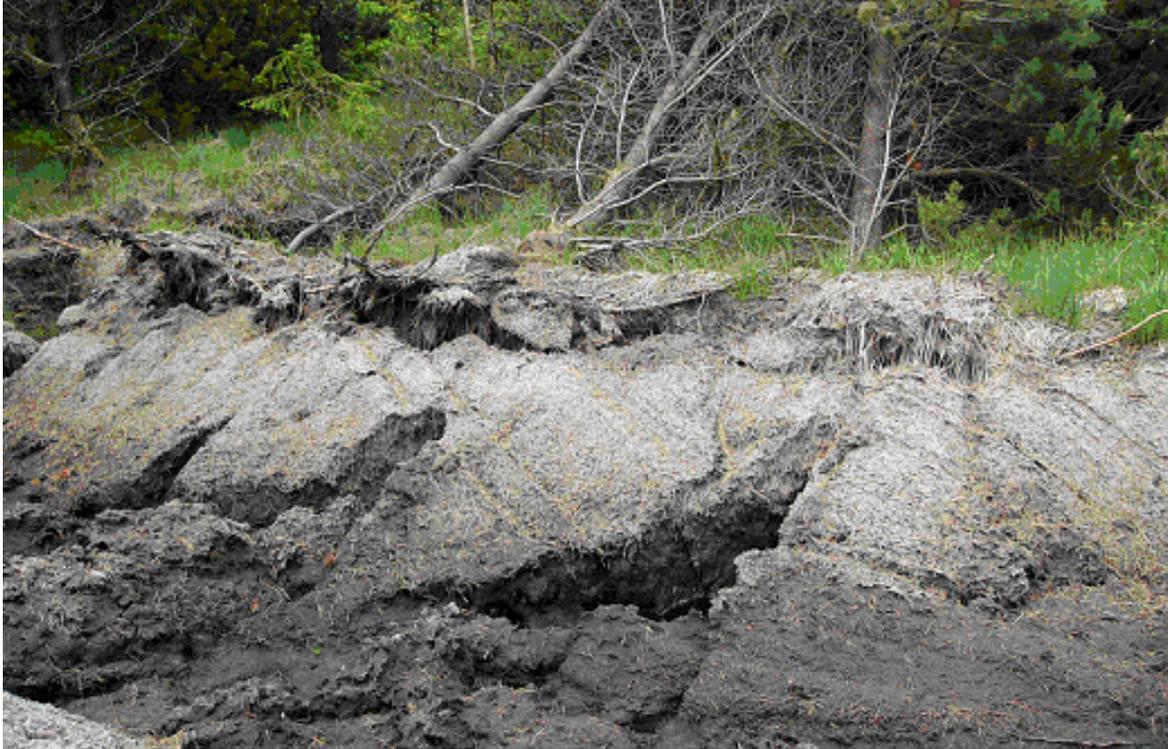
**Plate 8.6: Face of delaminated ribbon of peat. Note the depth of delamination and the tendency of tree roots to run along the line of the ribbon with few roots extending laterally at right angles to the ribbon. This suggests that there is relatively limited root growth across lines of the cracks that form under plantation conditions.**

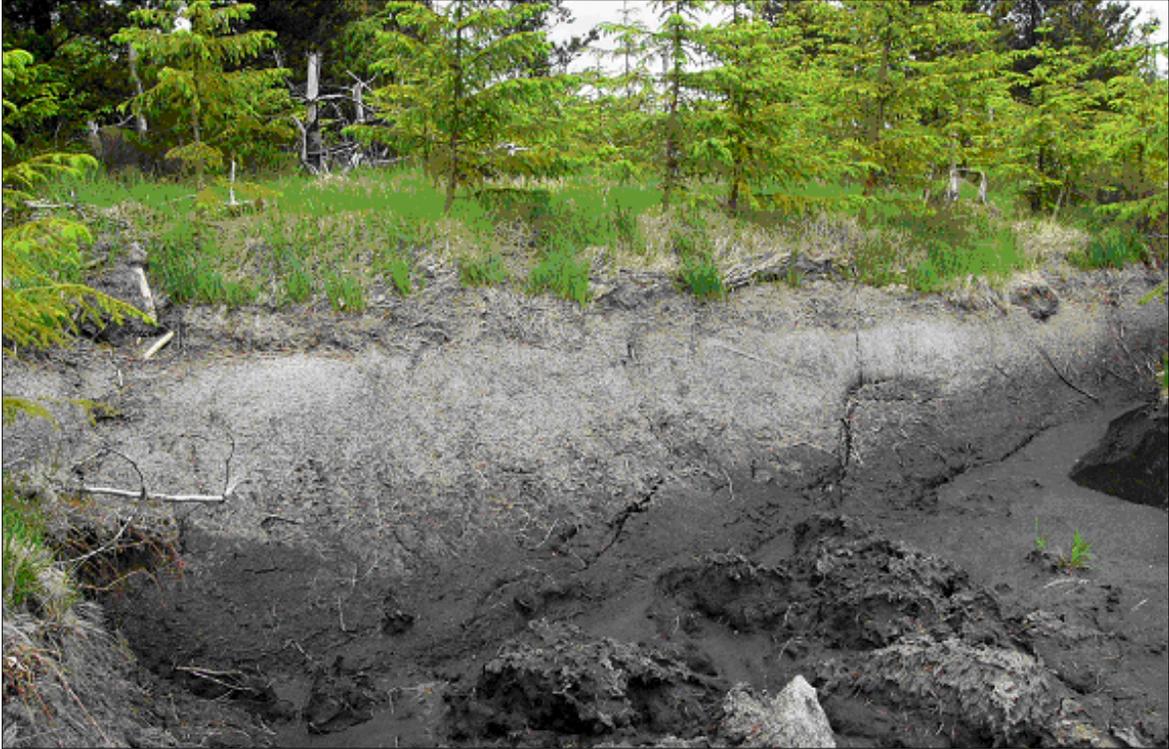
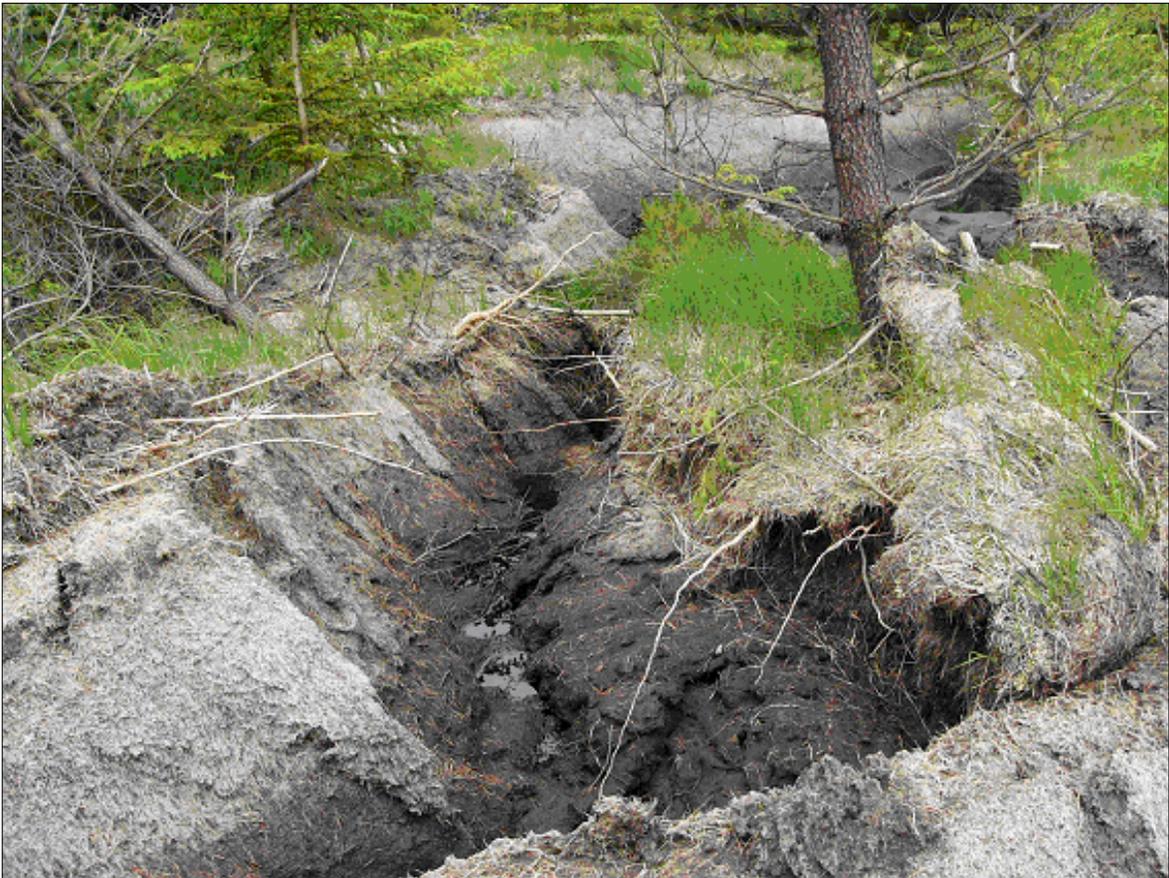
Plate 8.7: Delaminated ribbons of peat at the edge of the failed area near T70. The two-layered structure of the peat profile is obvious on the faces of the ribbons but there are few protruding tree roots. Some cracking of catotelm peat is evident in the upper picture.

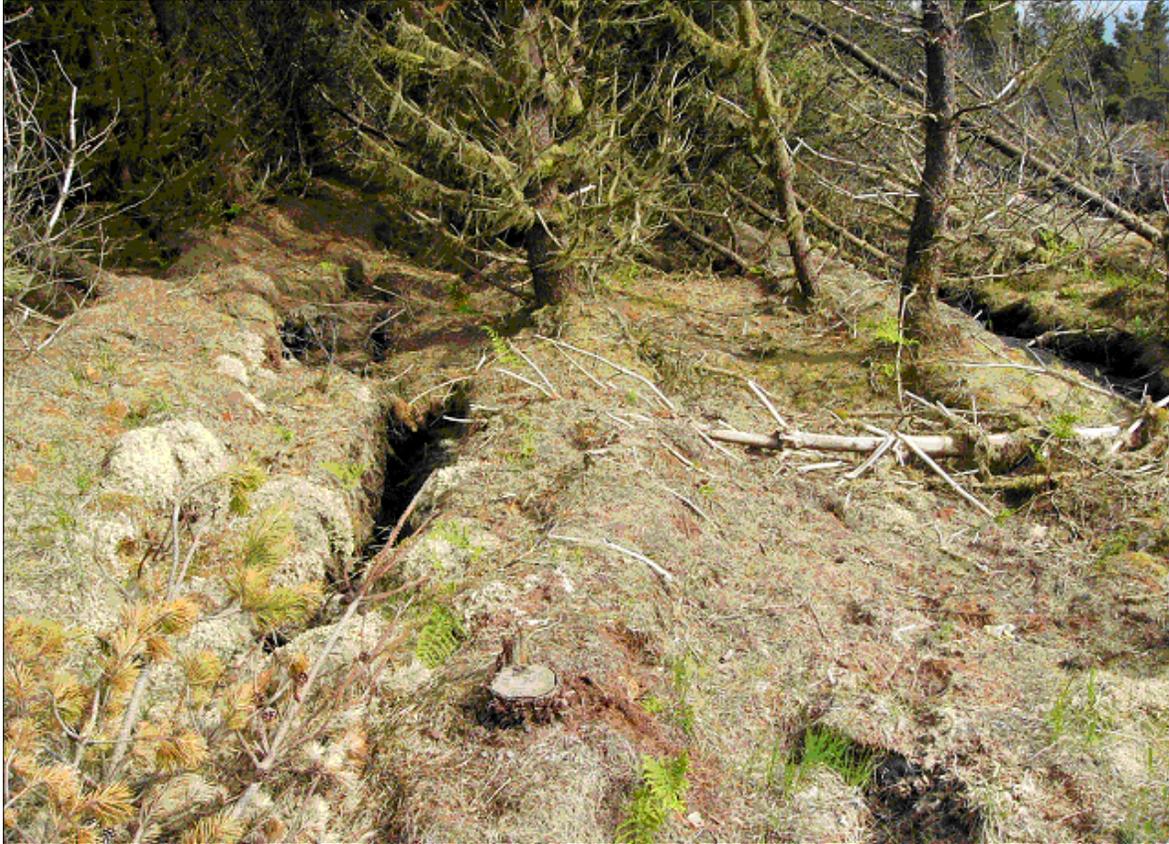
**Plate 8.8: A peat ribbon just beginning to separate along what appears to be a plough-furrow crack adjacent to the failed area.**

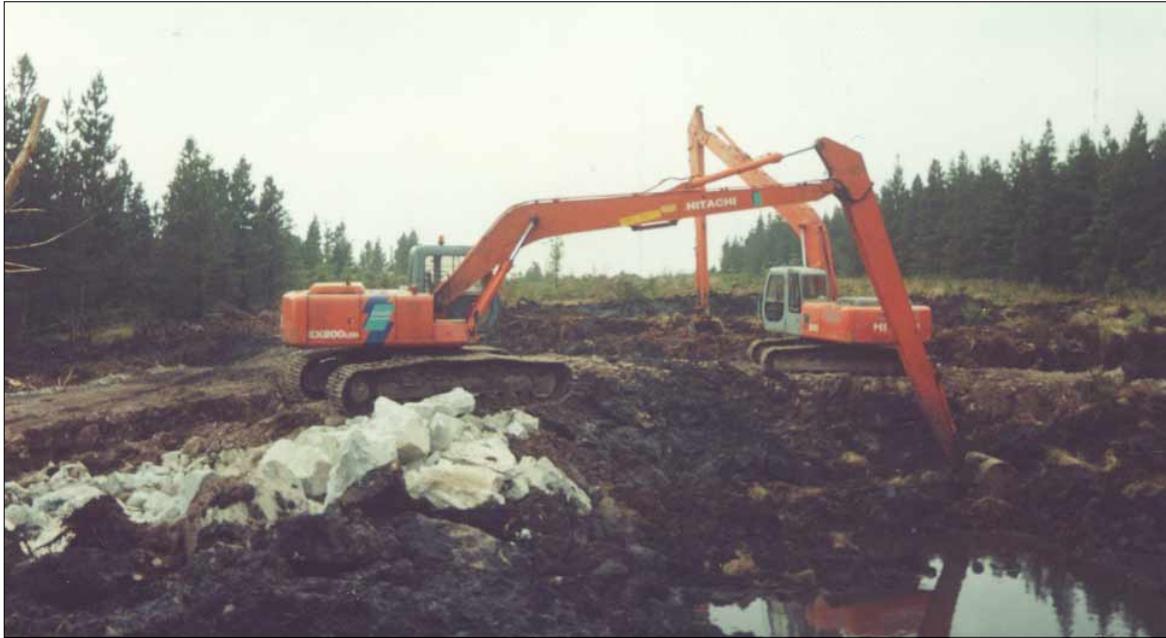
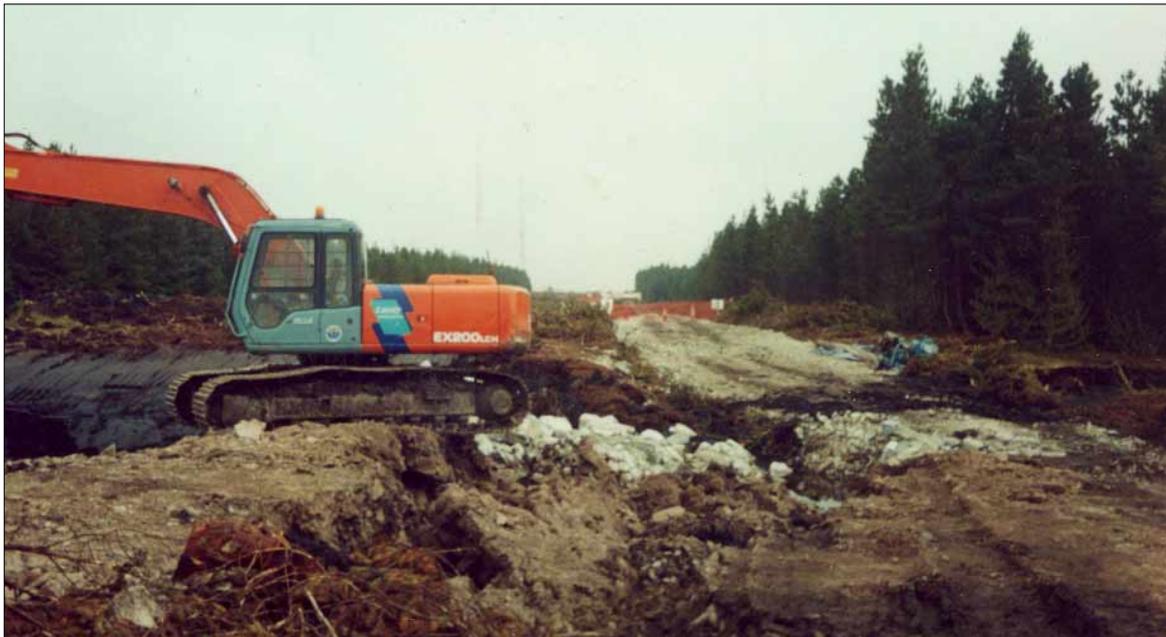
**Plate 8.9: T68 shortly after the bog slide. The head of the failure was marked by a tension crack which can be seen beneath the perched excavator and the access road bowed downslope (to the right of the lower picture, which was taken from the west side of the slide).**

The cause of the failure could not be specifically identified even by the geotechnical experts who visited the site within days and so viewed all the evidence in a 'fresh' state. However, whilst the weather and condition of the site due to forestry could be predisposing factors, it seems probable that the slide was actually triggered at either T68 or at T70 or by a combination of the factors at both sites

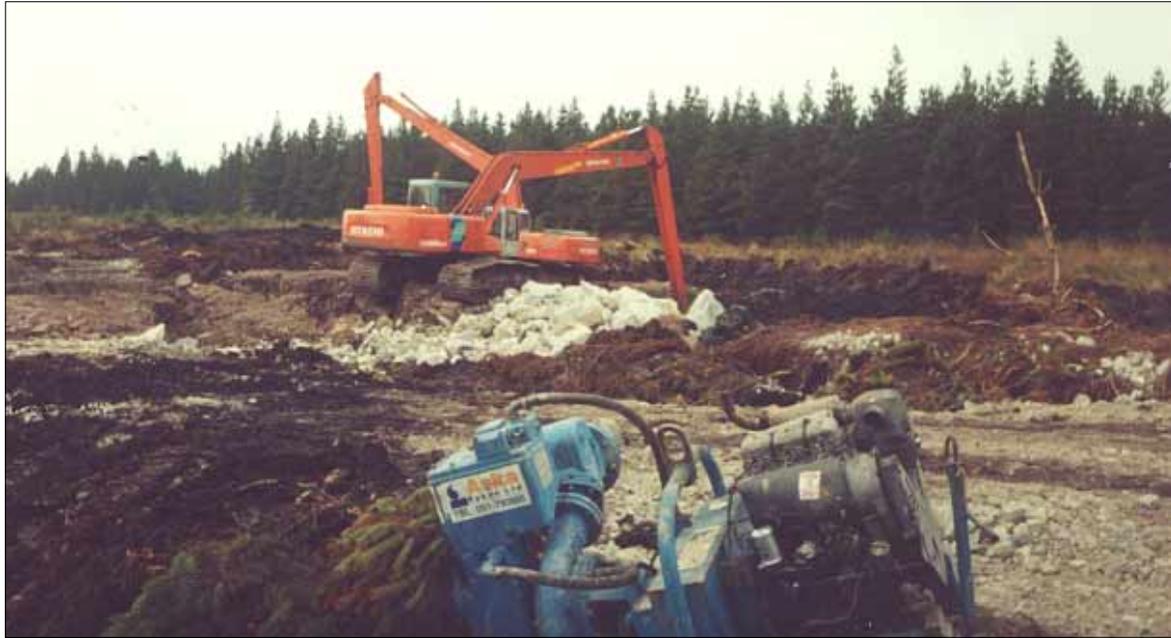
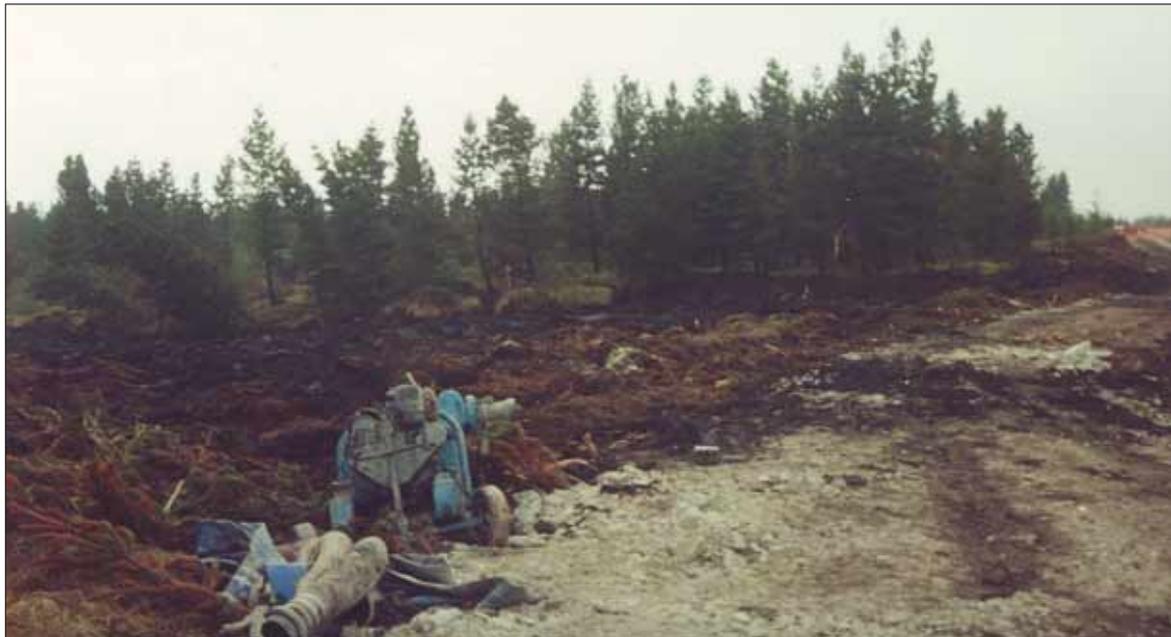
**Plate 8.10: Photographs taken at T68 shortly after the bog slide. A disconnected water pump features prominently in these frames, which were taken from south and east of the slide.**

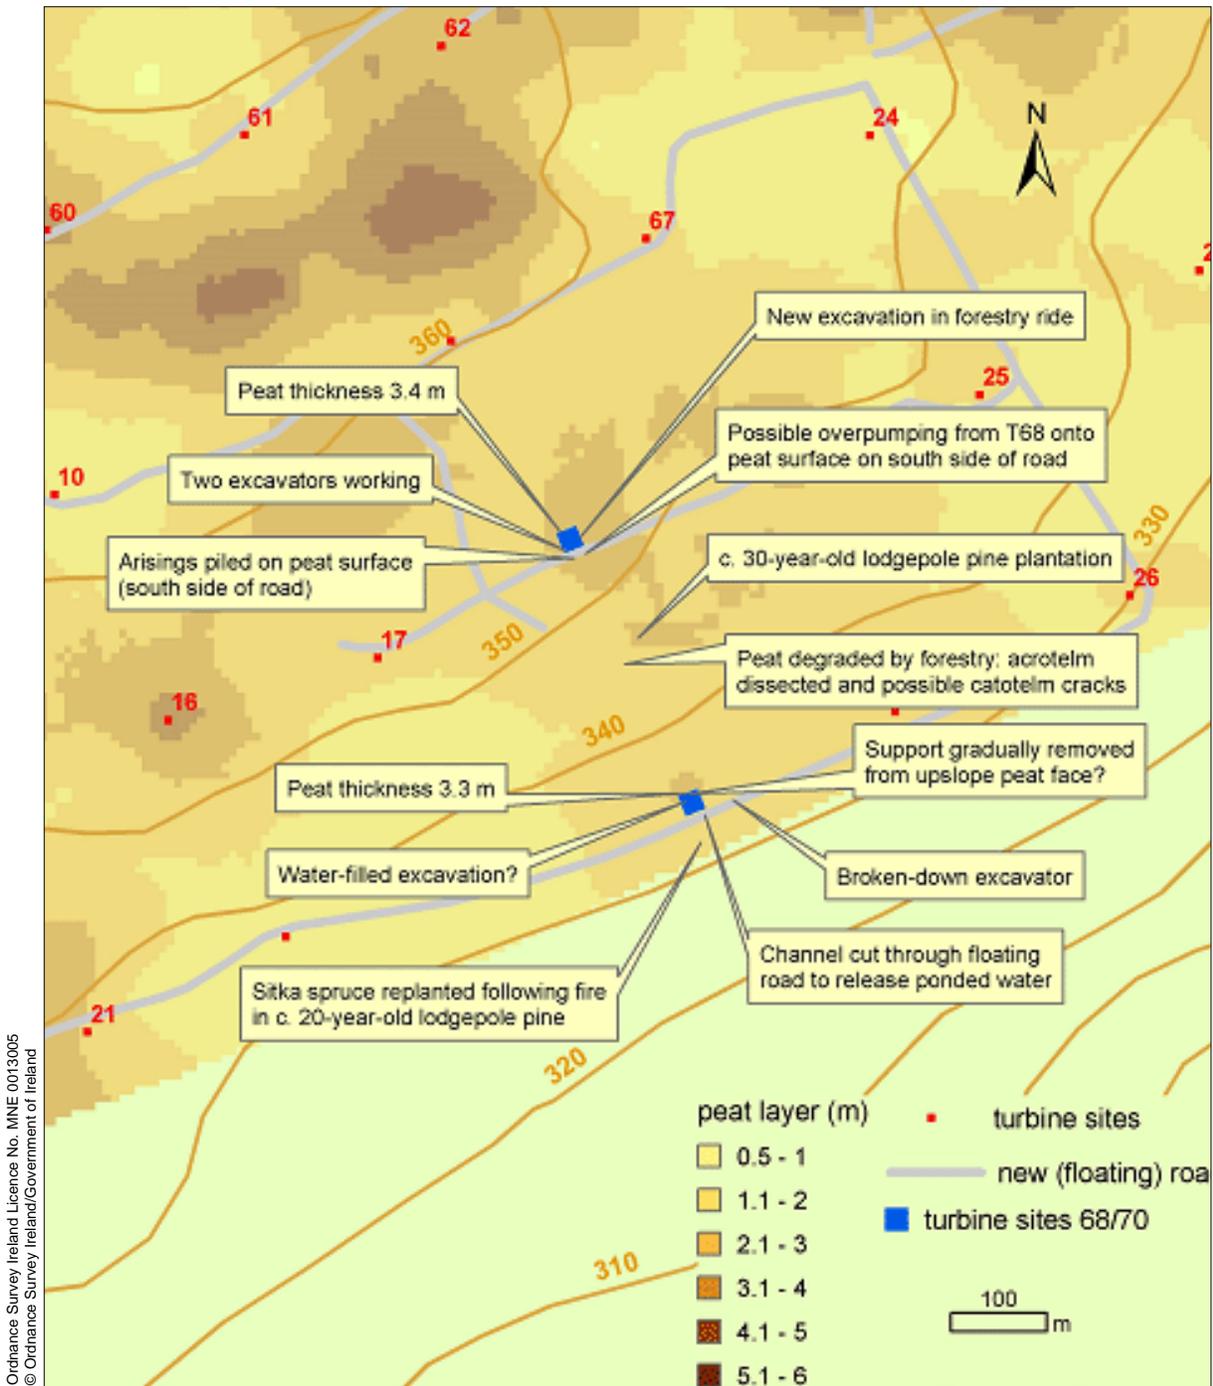
Figure 8.9: Factors that may have contributed to the bog slide at T68.

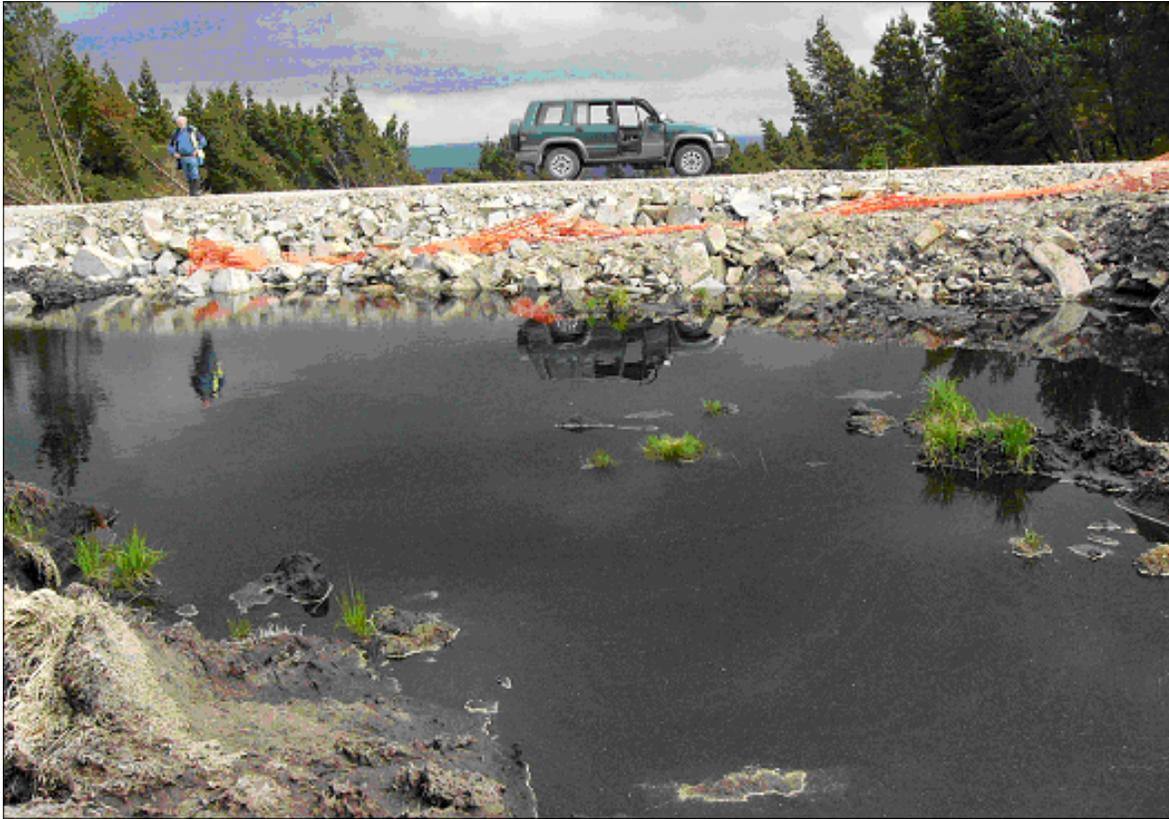
**Plate 8.11: A damaged floating road just by T68. By June 2004, when this photograph was taken, it had been top-loaded with some decimetres of rock and aggregate, presumably rendering it rather less permeable to water than previously. A considerable depth of water had accumulated upslope, as the picture shows.**
