# Wind farms and blanket peat

a report on the Derrybrien bog slide

**The Bog Slide of 16th October 2003  
at Derrybrien, Co. Galway, Ireland**

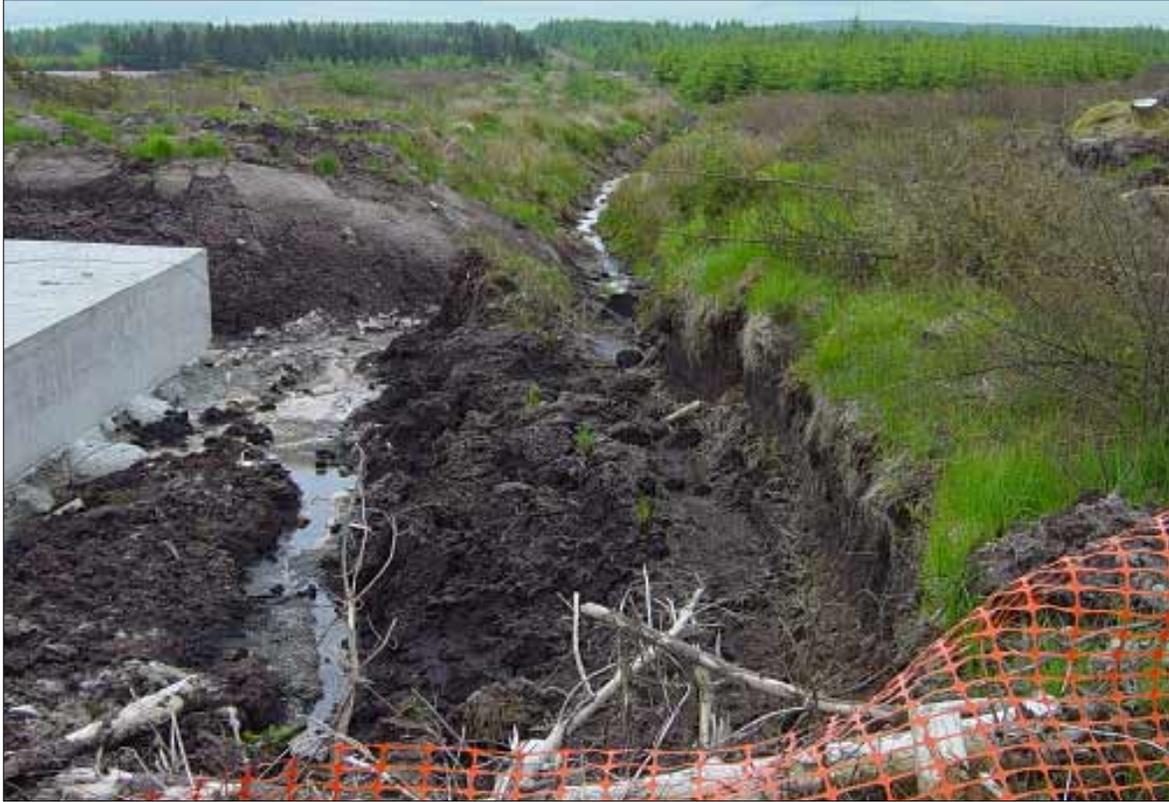
**Plate 9.1: The excavation at T17 lies on the line of an already-existing double ditch and so is well drained. Nonetheless, it was the site of the first substantial bog slide.**

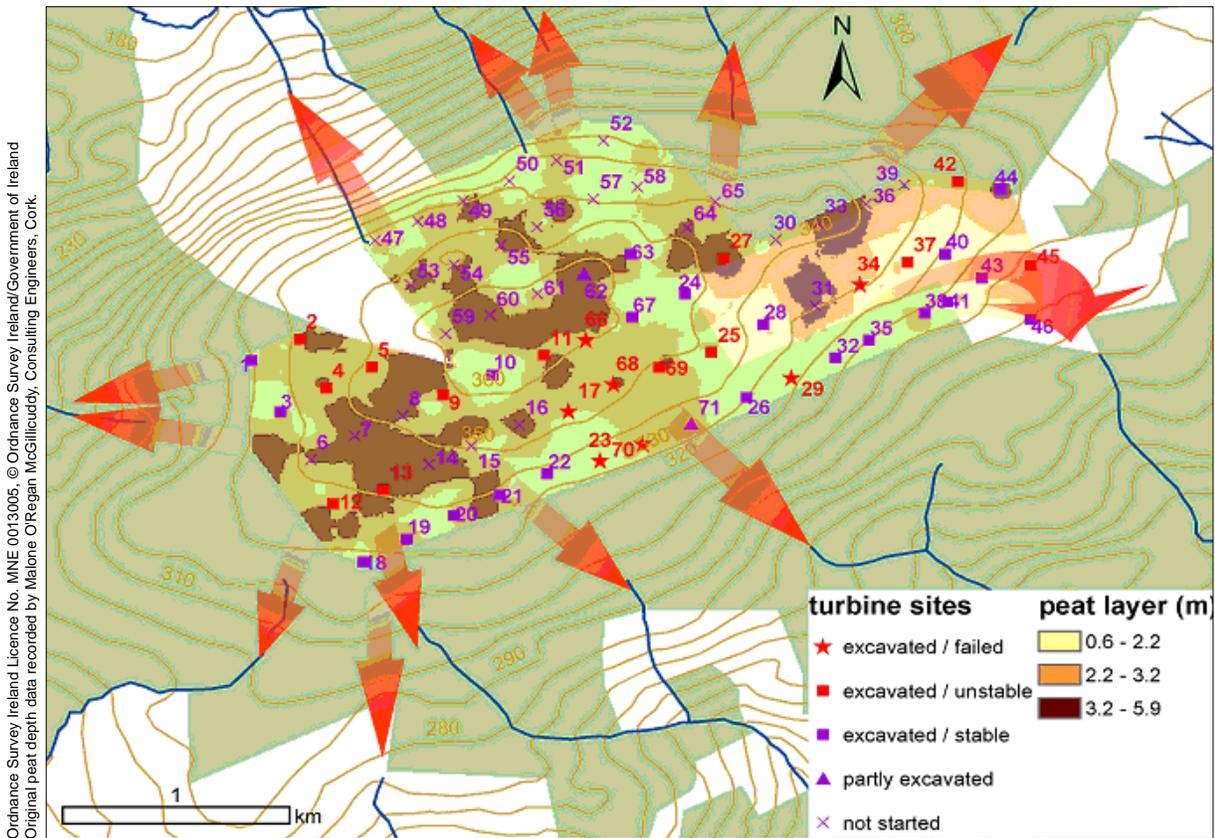
**Figure 10.1:** Distribution of differing peat depths within the area of the wind farm also showing the forest cover and locations of the turbine bases. These are coded according to their state of development and their assessed condition of stability. The red arrows highlight the likely direction of any peat movement towards stream

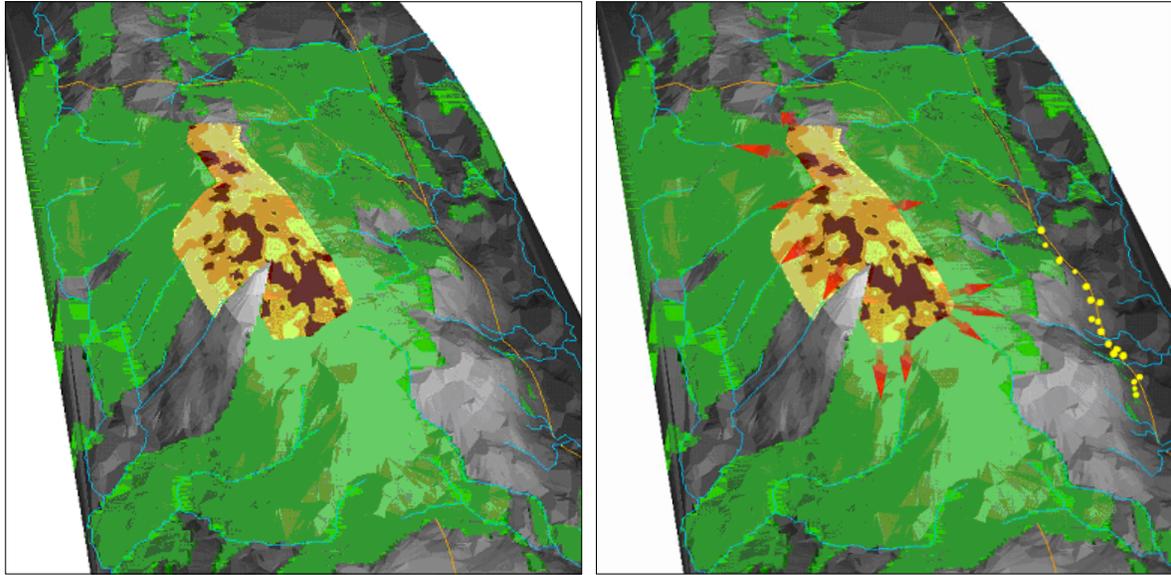
Figure 10.2a, above left: Three-dimensional view of the Cashlaundrumlahan summit from the WNW. It shows showing the extent of forestry (green shading), stream-courses (blue), roads (brown) and the depth of peat in the wind farm

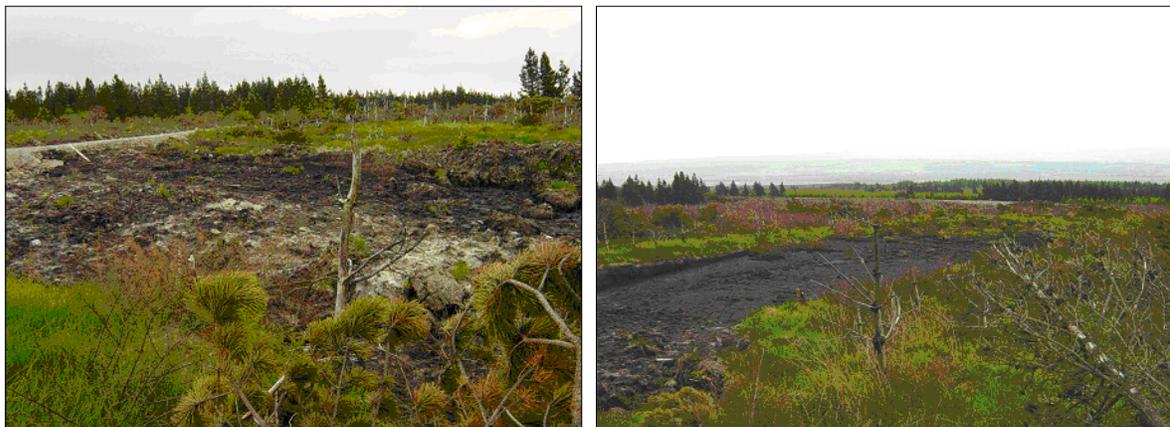
**Plate 10.1:** The scene of the bog slide that occurred at T17 only two weeks before the main slide. As can be seen from the small size of the trees in this vicinity, it includes areas that have already been drained for forestry, then suffered fire damage and were then drained again at replanting. So, although the area has been subject to considerable drainage, it has clearly not prevented peat failure.

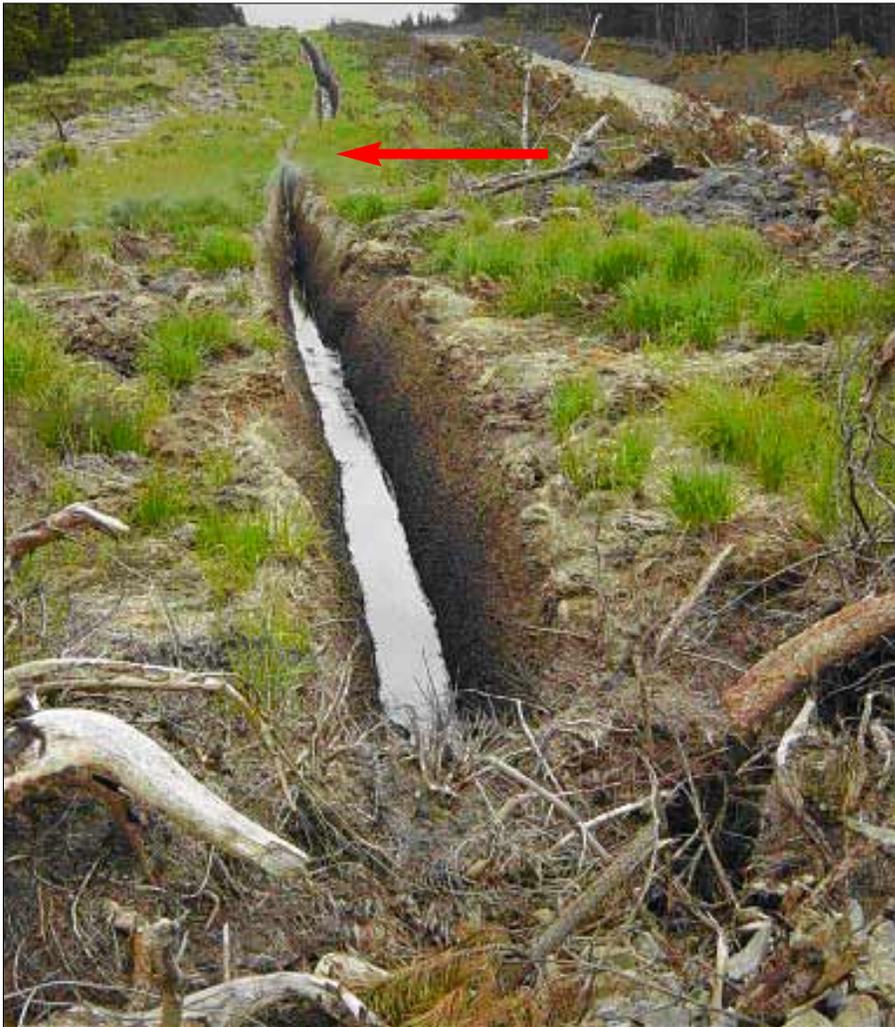
**Plate 10.2:** A ditch that runs ENE from T53 alongside a floating road across the northern slope of the mountain has obviously bowed and slumped downslope where it crosses deep peat. (It is assumed it originally ran straight.)

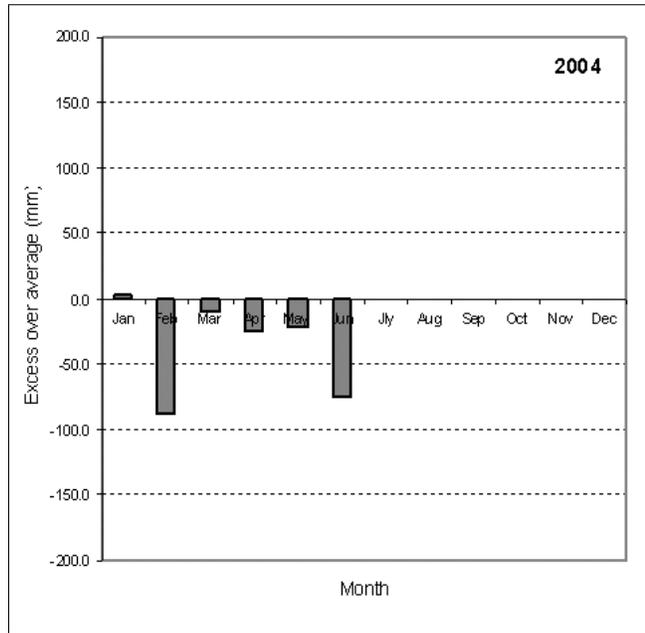
Figure 10.4: Monthly rainfall data for Derrybrien, 2004. Each bar indicates the deviation of the month's rainfall total from the appropriate 14-year monthly mean.

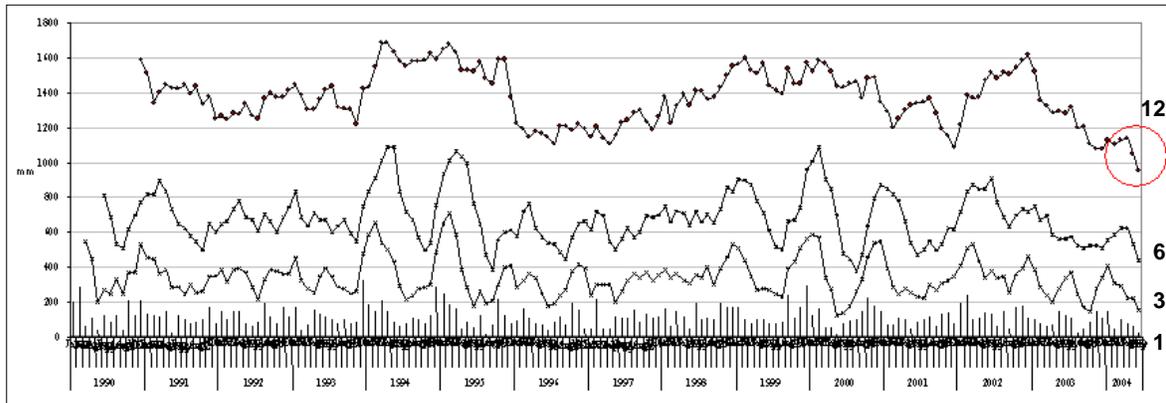
Figure 10.5: Monthly rainfall totals for Derrybrien, January 1990 to June 2004. The vertical bars at the bottom of the diagram (labelled 1) indicate monthly rainfall totals and the continuous lines indicate the accumulated rainfall for the three, six and twelve months preceding the last day of each month. The moving 12-month rainfall total for 2004 (circled in red) is the lowest in data series at 952mm.

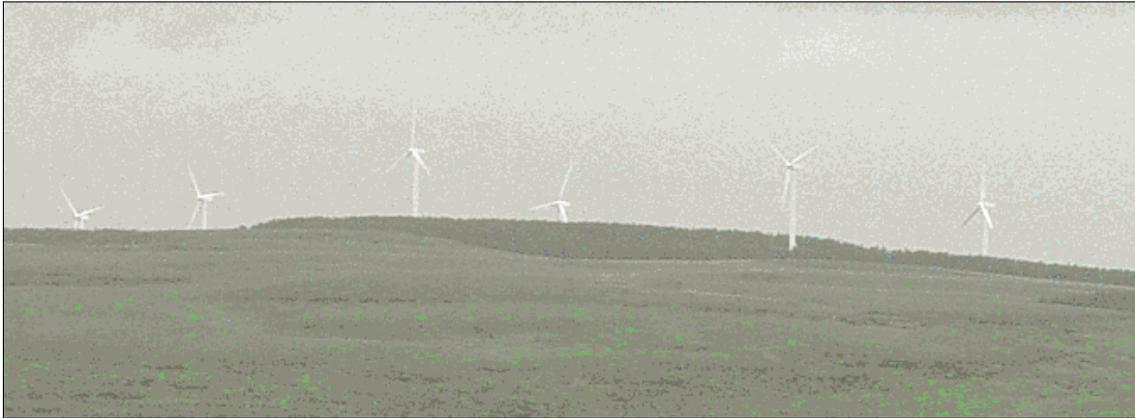
Plate 10.3a, above: The recently-erected 9-turbine wind farm at Sonnagh Old, four km to the north of the Derrybrien scheme from which this photograph was taken.

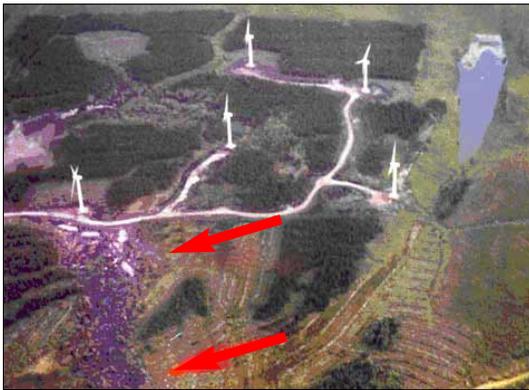
Plate 10.3b, above: The point of origin of the bog slide at Sonnagh Old, shown by the arrows.  
 Plate 10.3c, right: The full extent of the slide at Sonnagh Old. The forestry associated with Cashlaundrumlahan can be seen in the distance (indicated by the arrow at the top of the photograph).
