Exterior Refurbishment and Fire Safety Strategies for High-Rise Council Estates in the UK

Abstract: This research investigates the current exterior refurbishment strategies for high-rise council estates with the aim to enhance fire regulations and reduce risk of fire in buildings. This research outlines the main causes of the catastrophic Grenfell Tower fire and the current Building Regulations that were enforced during the time of its exterior refurbishment (i.e. replacement of fabric/cladding). Potential recommendations/enhancements made subsequent to the Grenfell Tower fire, proposed by the relevant institutions and its professionals, are analysed. A case study based in the borough of Westminster is then analysed in order to assess its proposed exterior refurbishment strategy in relation to compliance with the building regulations and safety requirements. The results reveal that although the refurbishment strategies have improved, there are some defects in the enforcement of the regulatory systems that should be addressed.

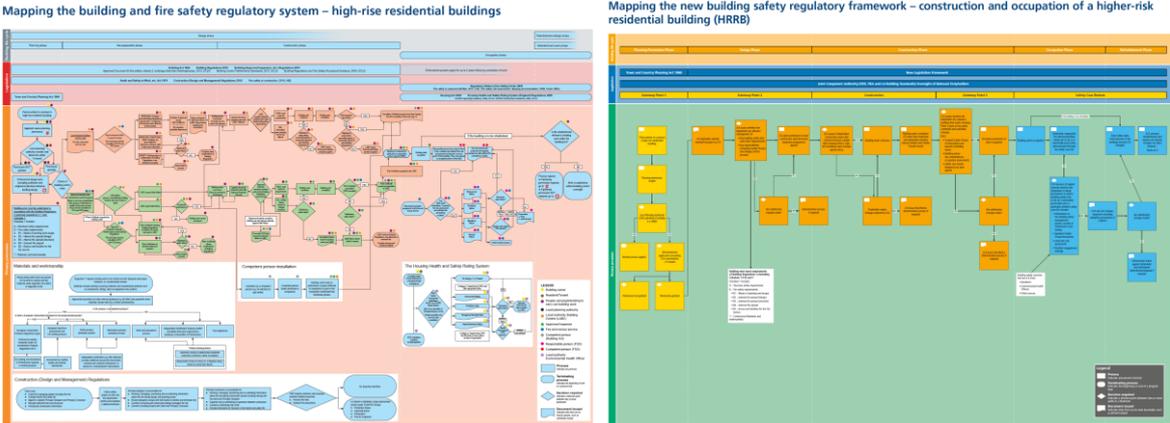
Figure 1. Mapping the building and fire safety regulatory system- a: old framework (left); b: new framework (right) [19,20].

A new regulatory framework for multi-occupancy Higher risk residential buildings (HRRBs) has been developed specifically for buildings of 10 or more storeys. Figure 1(a) [19] indicates the map of the previous regulatory system in place and Figure 1(b) [20] indicates the new proposed map. The old map was highly complex and had “overlapping” sets of legislations which had made it harder to understand and follow. However, the new HRRBs map has been refined and is easier to follow, ensuring its use is effective and beneficial [18]. The main purpose of the maps is to give assistance and guidelines for constructing and maintaining high-rise residential buildings. This is represented in the form of a flow chart which, in each section, includes legislations/building regulations that must be abided by. The UK Government is strongly considering restricting or even banning desktop studies-especially on cladding systems [21]. The Government is also working on improvements to Building Regulations fire safety guidance.

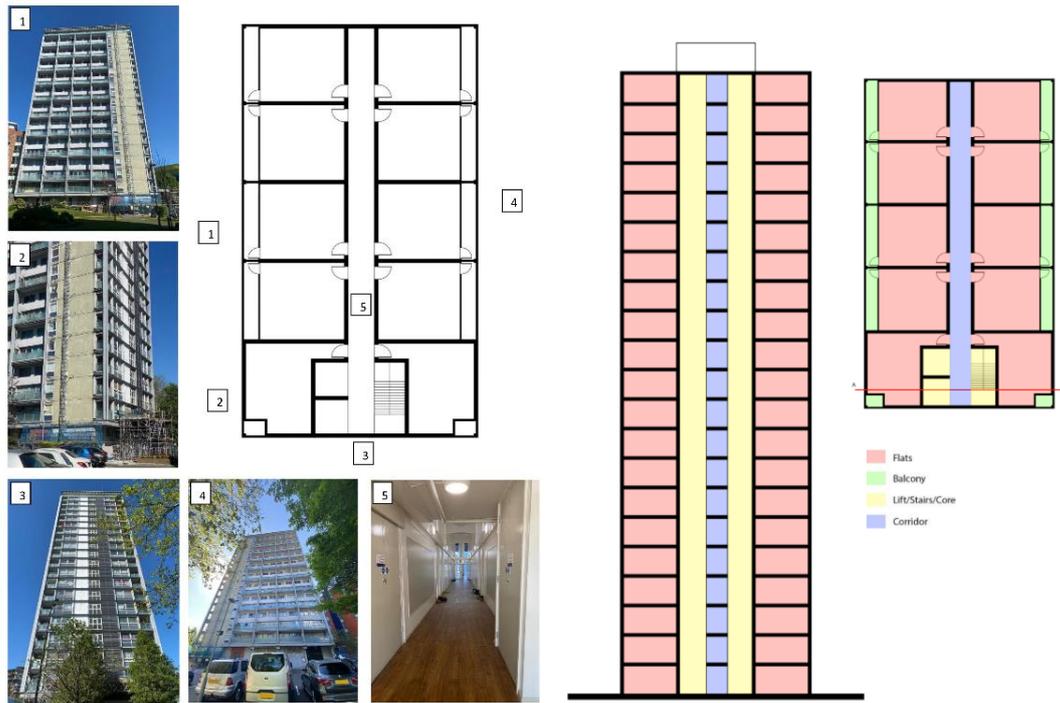
Figure 3. The case study building “Polesworth house”; an approximate section and plan.

To analyse the building and the current stage of its cladding system replacement, a visit to the site was made and a photographic survey was carried out. These images indicate that the combustible cladding system was taken down, exposing the original building façade (Figure 3).

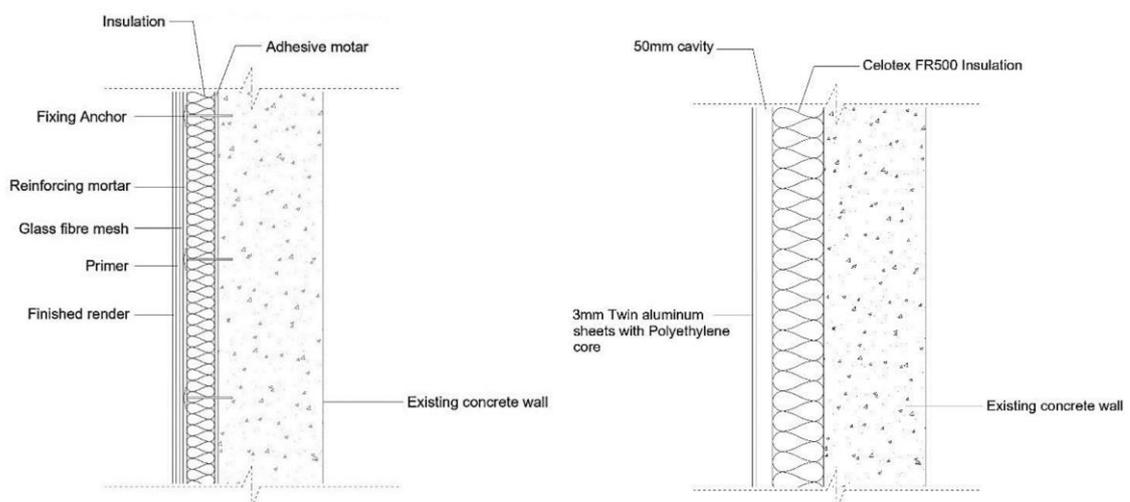
Figure 4. On the left is a wall detail of the proposed exterior refurbishment strategy (EWI) for “Polesworth house”, compared to a wall detail of the previous cladding strategy.

In terms of the new exterior refurbishment strategy (Figure 4), the council taken a different approach and is proposing to install a refurbishment system referred to as the “external wall insulation” (EWI) rendering system [29,30]. Comparing this external wall insulation cladding system to the ACM cladding system, one of the main reasons for this consideration was the fact that the main system is recognised as an A1 system, meaning that it is completely non-combustible. According to The Green Age [31], EWI is not recognised as a rainscreen cladding nor a cladding system in general, which means that it would not be subject to any ongoing testing criteria. This results in a rapid installation process. There are other reasons as to why EWI is preferred over ACM. Table 1 summarises the advantages and disadvantages of the systems.

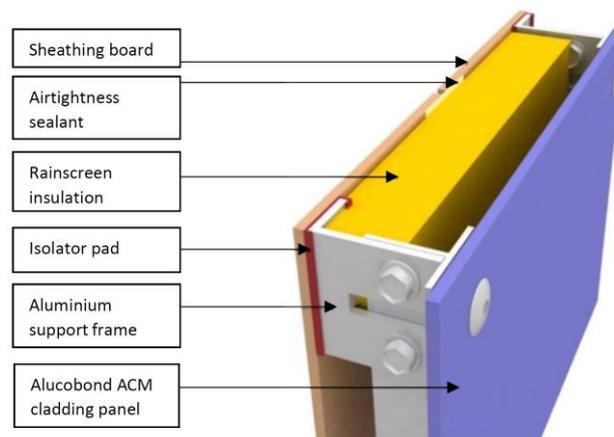
Figure 5. A typical assembly of the “Alucobond” ACM system [32].

When it comes to the refurbishment of other high-rise domestic buildings, EWI (exterior wall insulation) systems may not be the best option as, in some cases, they are classified as ‘non-aesthetically pleasing’; this is subjective but entirely depends on the client. In this case, there are multiple manufacturers who produce ACM (aluminium composite material) cladding systems that are classified as non-flammable. An example of this is referred to as “Alucobond A2”, which, according to RCM building boards & facades [32], is an ACM cladding system that can be used for buildings over 18m. The system consists of two aluminium cover sheets filled with a mineral polymer core, which has high levels of rigidity and impact resistance, which therefore means it has superior durability overall in comparison to other available products. Most importantly, it is non-flammable and abides by the current fire rating standards “EN 13501-1 class A2-s1,d0”. Figure 5 illustrates a typical assembly of how the system is put together [32].
