# Moment-rotation response of nominally pinned beam-to-column joints for frames of pultruded fibre reinforced polymer

Jawed Qureshi <sup>a,\*</sup>, J. Toby Mottram <sup>b,1</sup>

This paper presents the test results to characterise the moment-rotation response of nominally pinned joints in frames of pultruded shapes. Mimicking conventional steel construction the major-axis beam-to-column joints are formed using pultruded FRP web cleats having steel bolting. There are two joint configurations with either a single row of three or two bolts per cleat leg. Testing is conducted on nominally identical specimens to statistically quantify the key joint properties. The average stiffness of all joints at damage onset is found to be 50% more variable than the average moment resistance. The presence of 70% difference between the minimum and maximum initial stiffness measured makes a single specimen measurement for stiffness unsuitable for frame analysis. The initial stiffness of the two joint configurations classifies them to be nominally pinned. No appreciable difference in characteristics for the three and two bolt configurations is found; the middle-bolt is unnecessary as two bolts give

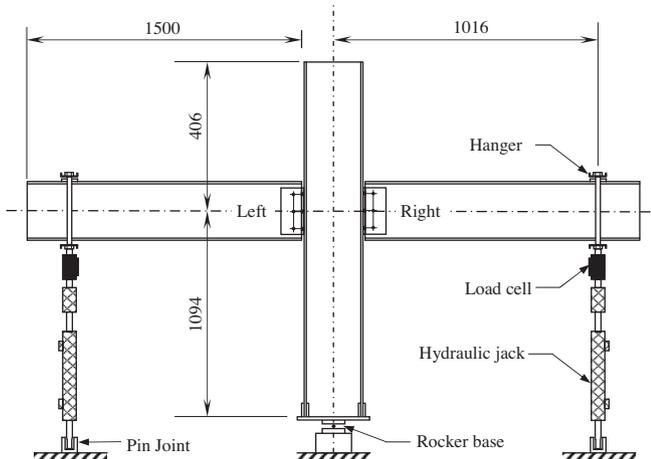
Fig. 1. Cruciform test configuration (all dimensions are in mm).

The longitudinal centreline of the beams is set at a vertical distance of 1094 mm from the base of the column. This height is dictated by the dimensions of hydraulic jacks and base fixtures. The bottom end of the column is placed on a steel rocker base fixture, which allows ‘free’ in-plane rotation (in the plane of Fig. 1) to justify the assumption of a pinned base. The reason for using a pinned column base is to make sure that both Left and Right beams are subjected to the same load.

Load is applied through a hanger assembly and a ball bearing (12.7 mm) placed in a hemi-spherical socket at the centre of a steel loading plate illustrated in Fig. 1. This arrangement ensures vertical alignment of the load with minimal axial force components. Loading is applied at distances of 1016 mm from the column’s centreline. The distance of 1016 mm is dictated by the layout of the anchor points on the strong floor, which are spaced at 406 mm centres. The applied force is measured by two tension load cells, each

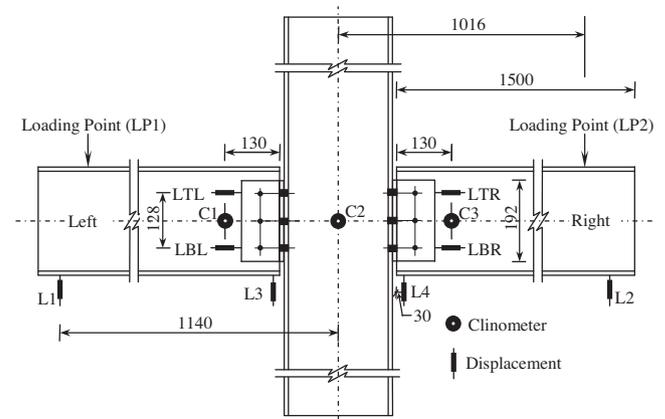
Fig. 2. Location of instrumentation in nominally pinned beam-to-column joint tests (all dimensions are in mm).

Locations of the instrumentation are shown in Figs. 2 and 3 shows a specimen under test. In the specimen labelling scheme, L is for Left-side and R for Right-side in a pair of joints. Rotations and displacements are measured, at each increment and after a time lapse of five minutes, using clinometers and strain gauge

Relative slip between a pair of web cleats and the beam is measured by four displacement transducers, designated in Fig. 2 as LTL, LBL, LTR and LBR. The first letter, L, in label LTL denotes there is a vertical separation between the two horizontal transducers, and second and third letters denote Top bolt on Left-side of the specimen. The displacement transducers L1 and L2 measure the vertical deflection of the beam at the loaded ends. While L3 and L4 measure vertical slip at the joints on the Left and Right sides.

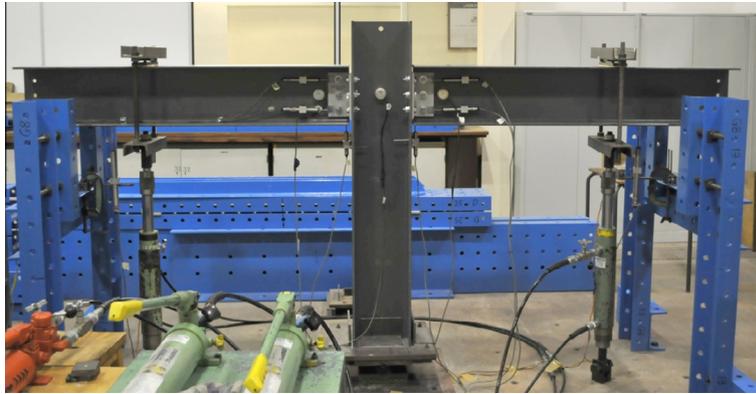
Fig. 3. General test arrangement for beam-to-column joints.

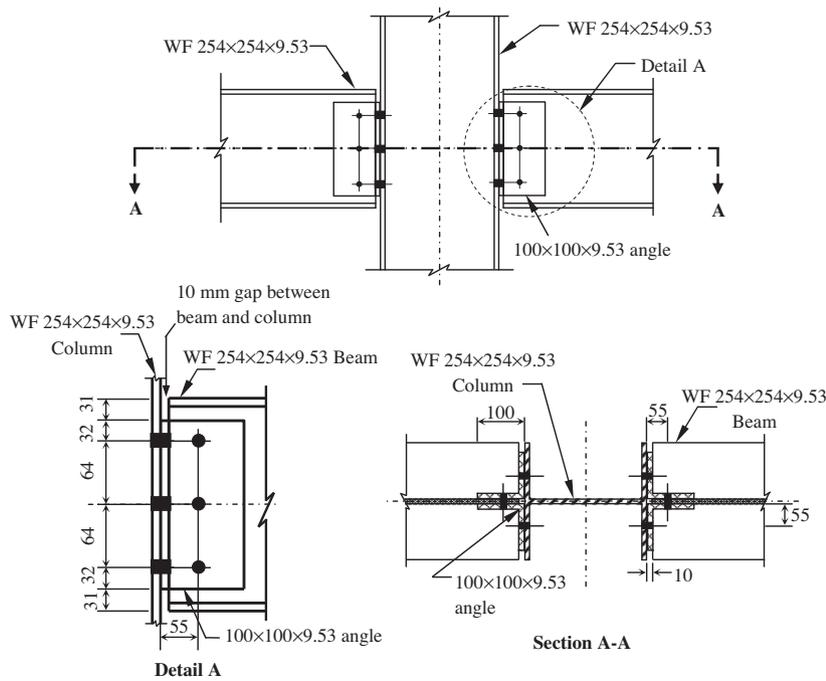
Fig. 4. Connection details for nominally pinned beam-to-column joint tests (all dimensions are in mm).

Fig. 4 shows connection details, prepared in accordance with drawings in the Strongwell Design Manual [4] and clauses in an ASCE Pre-Standard [24]. Bolting is standard size steel bolts of M16 grade 8.8 with standard  $\phi$  35 mm by 3 mm thick steel washers. The portion of bolt shaft bearing onto FRP material is unthreaded. Bolts are tightened to the snug-tight condition, achieved by tightening the bolt to full effort of a worker using a hand operated wrench [27]. This level of bolt tightening is achieved as per guidance for the snug-tight condition in [28–29].

This test series consists of two joint configurations [4] with a single row of either three or two bolts per cleat leg. To form the two-bolt configuration the central bolt in Fig. 4 was removed (see Fig. 5). Joints having three bolts are denoted by Wmj254\_3M16\_FC and having two bolts by Wmj254\_2M16\_FC. Labelling is for a  $254 \times 254 \times 9.53$  mm web-cleated beam and major axis column, with a single row of 3 M16 or 2 M16 bolts in a FRP web cleat. All other test conditions are the same for the two- and three-bolted configurations.

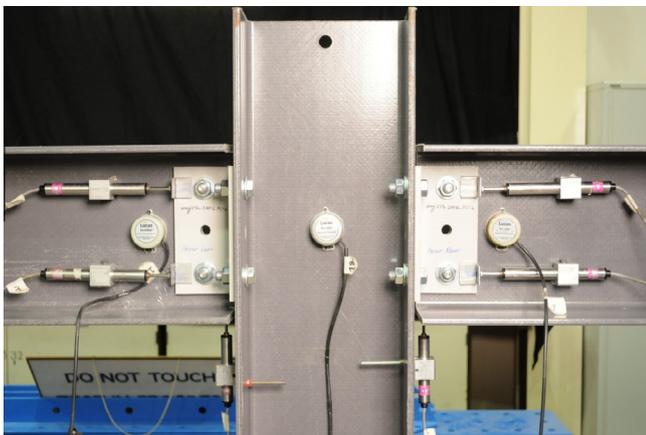
Fig. 5. Details of beam-to-column joint test Wmj254\_2M16\_FC.

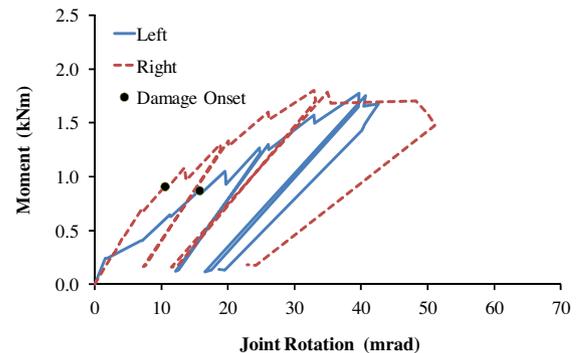
**Fig. 6.** Moment-rotation curves for Wmj254\_3M16\_FC1.5 (with slip rotation).

$M$ - $\phi$  curves for specimens Wmj254\_3M16\_FC1.5 and Wmj254\_2M16\_FC1.2, with rotation slip, are presented in Figs. 6 and 7. Plotted in Figs. 8 and 9 are the same results after  $\phi_{slip}$  has been removed. The Left-side is given by the solid line curve and the Right-side by the dashed line curve.  $M$  and  $\phi$  values at damage onset are represented in the figures by the solid circle symbols. When two joint values are given in the following discussion the first is for the Left-side and the second for the Right-side.

For Wmj254\_3M16\_FC1.5 the slip rotations at damage onset are 6 and 0.8 mrad. Because this bolt slippage is present, the two  $M$ - $\phi$  curves in Fig. 6 are quite different in shape, and  $\phi_j$  is 15.7 and 10.5 mrad. This compares with 9.7 mrad (for both joints) in Fig. 8 when  $\phi_{slip}$  is accounted for. When slippage is involved, the curves in Fig. 6 give the impression that the Left joint has a nonlinear response from a low  $M$  of 0.25 kNm. Because there was no delamination damage at this moment the nonlinearity is seen to be solely due to slip rotation. When  $\phi_{slip}$  is removed, the  $M$ - $\phi$  response of both joint sides is found to be equivalent, until the onset of FRP failure at  $\phi_j$ .

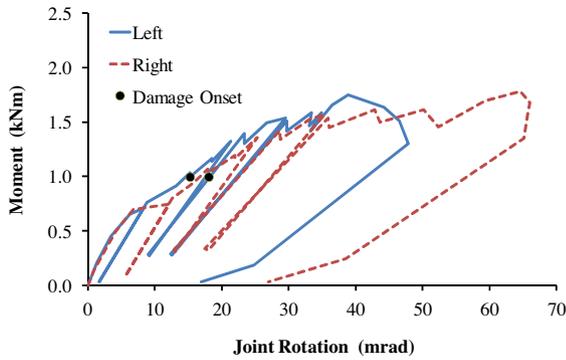
Fig. 7. Moment-rotation curves for Wmj254\_2M16\_FC1.2 (with slip rotation).

The existence of  $\phi_{slip}$  in Wmj254\_2M16\_FC1.2. (Fig. 7) increases  $\phi_j$  to 15.2 and 18 mrad. Following slip compensation, the pair of  $\phi_j$ s are lower at 13.1 and 14.7 mrad (Fig. 9). This behaviour might lead the misinformed to misinterpret  $\phi_j$  that can be used when establishing a design limit for central deflection ( $w_c$ ) of a simply supported beam with a uniformly distributed load. The saw-tooth shape of the curves in Figs. 6–9 is due to  $M$ - $\phi$  readings being taken immediately after load application and after a lapse of

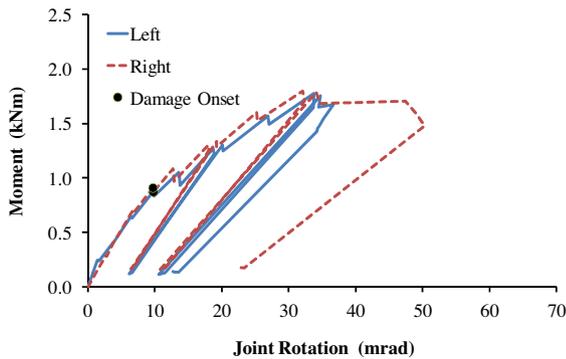
Fig. 8. Moment-rotation curves for Wmj254\_3M16\_FC1.5 (compensated for slip).

In Fig. 8 the response for the three-bolt configuration remains, approximately, linear elastic until the cleats start to delaminate. The  $M$ - $\phi$  curves become non-linear for moment  $>0.5$  kNm and the damage started when  $\phi_j$  is 9.7 mrad. To assess the extent of stiffness reduction, specimen Wmj254\_3M16\_FC1.5 was unloaded and reloaded after there was material damage. The results of these stages in testing are shown in Fig. 8.

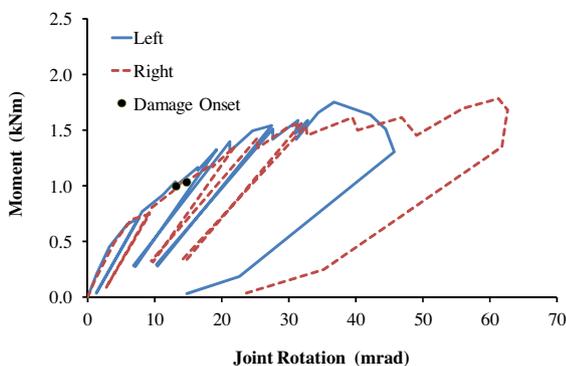
Fig. 9. Moment-rotation curves for Wmj254\_2M16\_FC1.2 (compensated for slip).

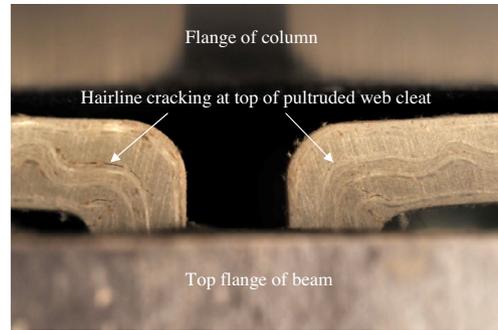
Fig. 10. Close-up of damage onset near the fillet radius of a pair of web cleats in specimen Wmj254\_3M16\_FC1.5 (viewed from above).

All 16 joints (for eight (Left and Right) specimens) ultimately failed due to extensive delamination damage at the top of web cleats and near the fillet radius, as shown in Figs. 10 and 11. Audible acoustic emission provided the first evidence of the hairline (delamination) cracks seen in Fig. 10. These cracks are found to run along an interface between a layer of mat and unidirectional roving reinforcement. Fig. 10 shows that, through the leg-angle thickness, these layers are not at constant positions, and this test variability partially explains the variation in the rotation results ( $\phi_i$ ,  $\phi_j$  and  $\phi_{max}$ ) reported in Tables 1 and 2. After hairline cracks appeared, application of further deformation widens and lengthens them, and created new visible surface cracks. Because extensive damage reduced the moment capacity, one joint side would rotate more than the other, as seen in Fig. 12.

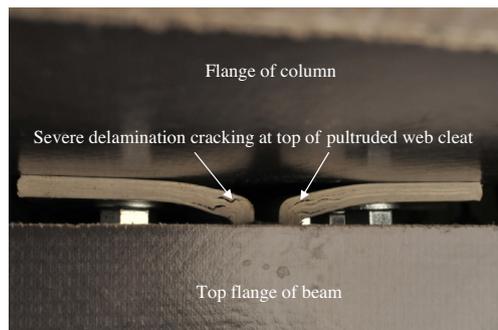
Fig. 11. Ultimate failure of a joint in specimen Wmj254\_3M16\_FC1.5 (viewed from above).

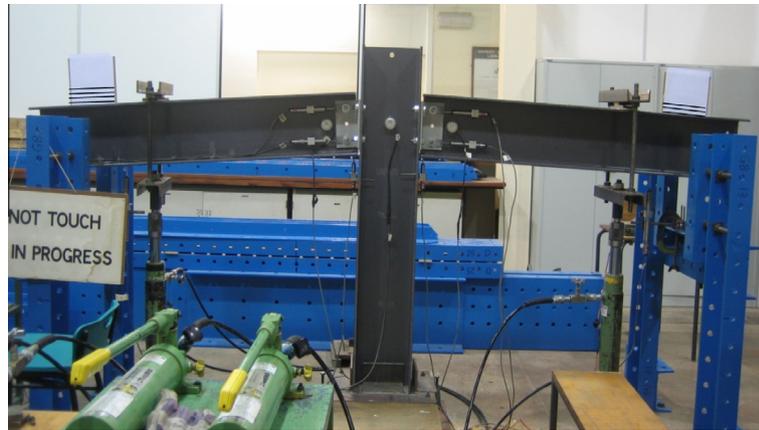
Fig. 12. Excessive joint rotation ( $\phi_{\max} \geq 37$  mrad) post-test with specimen Wmj254\_2M16\_FC1.2 (results in Table 2).
